Hancock Prospecting Pty Ltd

Alpha Coal Project (Rail)

Surface Water

September 2010

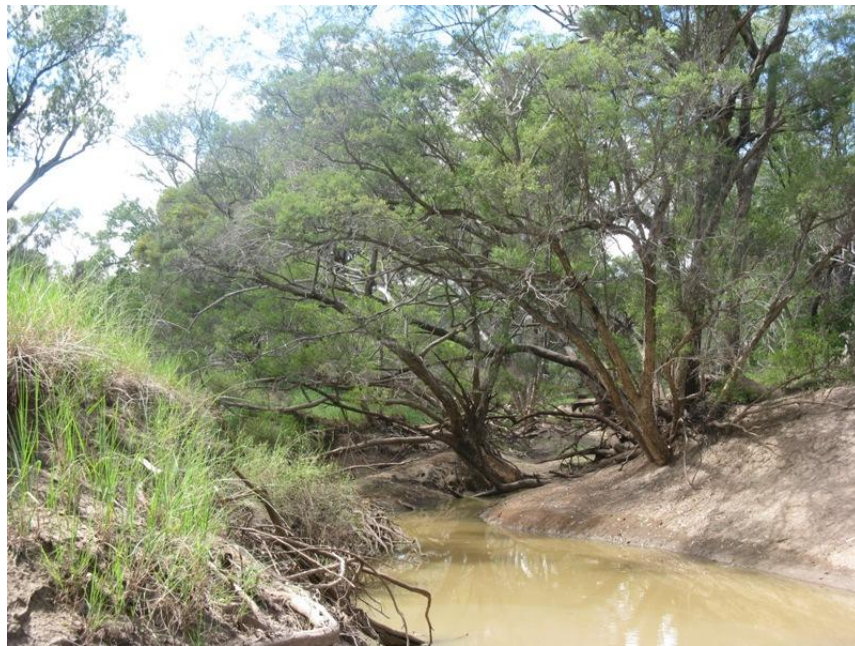
Figure 4 Belyando River

Banks are generally stable under the current flow regimes, many of which are stabilised by pasture grasses. Some limited bank instabilities are evident at all waterways, but in particular at the upstream end of the sub-basin. Native Companion Creek and Belyando river show the worst signs of erosion. More downstream waterways like Eagle Field Creek and Suttor River show less signs of erosion. All waterways show signs of degradation from cattle causing bank erosion.

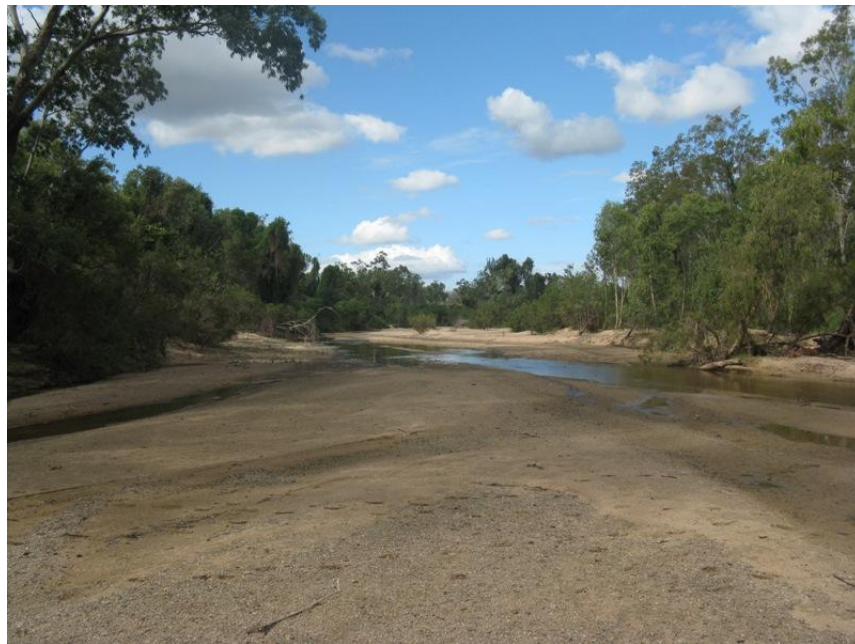
Figure 6 Pelican Creek

All waterways along the Project (within the Bowen Broken sub-basin) are considered to be relatively geomorphologically stable under current flow regimes. This is mainly due to extensive vegetation cover of the banks. All waterways show signs of degradation from cattle causing bank erosion.

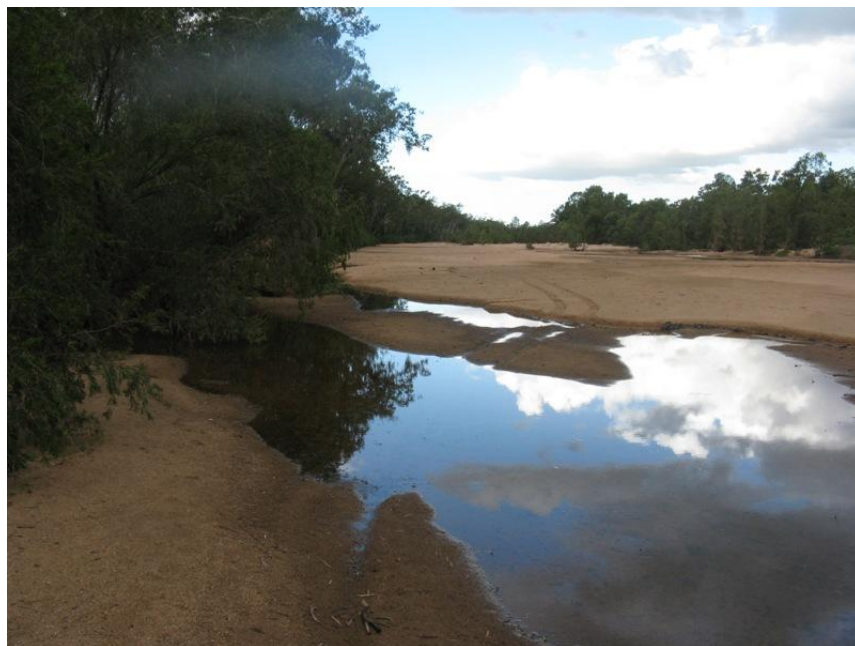
Figure 8 Bogie River

Banks are generally stable under the current flow regimes, mainly due to good vegetation cover. Although all waterways show signs of degradation from cattle, which can lead to bank erosion.

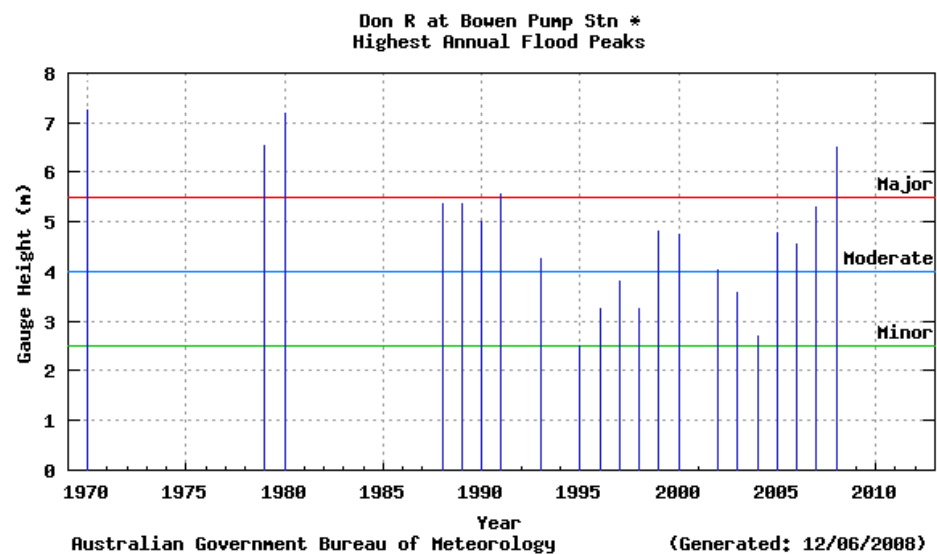
Figure 11 Floods in the DON River (BoM online)

Of the major tributaries and streams within the Don River Basin the Project alignment only crosses the Elliott River. No historic flood information has been found for this river. However, the frequency of flood events in the nearby Don River (refer to Figure 11) suggests the occasional flood event

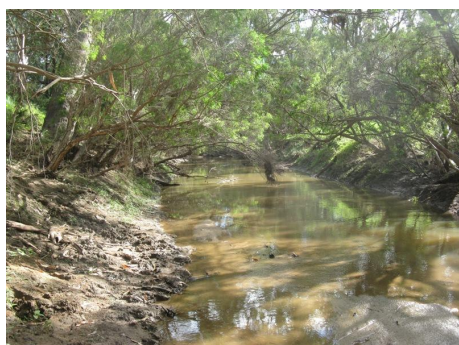
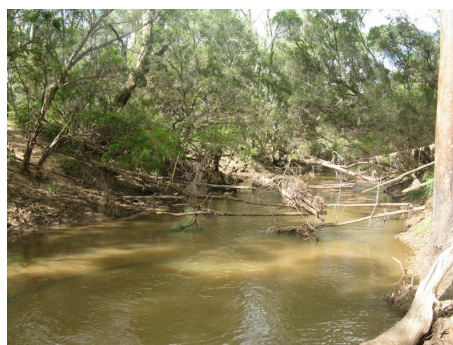
Waterway Crossing – 4

Channel Dimensions	Width of stream channel approximately 5m; width to top of bank approximately 30 m; average bank height approximately 4 m
Bed substrate	80% silt/clay; 15% gravel; 5% sand
Channel Sinuosity	Low
Channel Stability	Channel is stable with cohesive soils and extensive vegetation on the banks.
Banks	Unstable, banks 50% bare of vegetation and high cattle degradation.
Instream Features	Featureless trapezoidal channel.
Flow levels	Debris marks on a rope hanging high across the waterway.
Contextual Notes	Erosion channels enter creek on right bank.

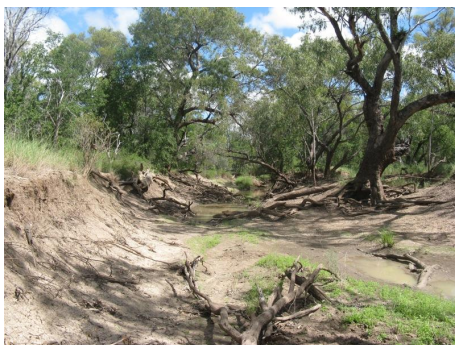
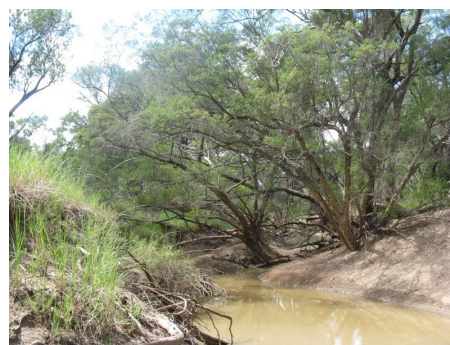
Waterway Crossing – 7

Waterway	Belyando River / Chainage 44000
Catchment	Belyando and Suttor sub-basin
Waterway Classification	Major Waterway
Land Use	Moderate to heavy grazing
Catchment Area	approximately 369,775 ha
Stream Order	46
Flow Frequency	Ephemeral

Channel Dimensions	Width of stream channel approximately 3 m; width to top of bank approximately 8 m; bank height approximately 2.5 m
Bed substrate	100% silt/clay
Channel Sinuosity	Low
Channel Stability	Channel is unstable with pools in the channel.
Banks	Unstable, small riparian zone and medium density bank vegetation.
Instream Features	Trapezoidal channel with in channel islands and pools.
Flow levels	No flood marks observed.
Contextual Notes	Moderate erosion; some silt/clay deposition on banks

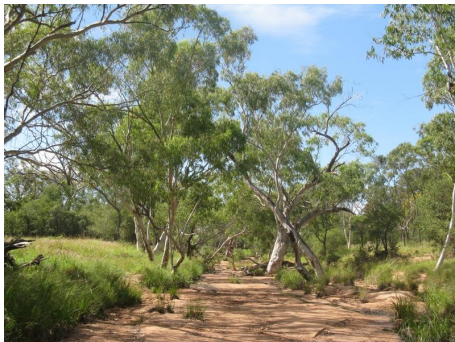
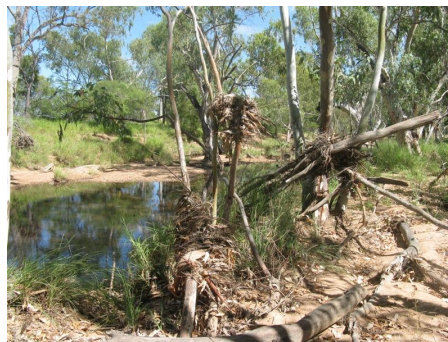
Waterway Crossing – 9

Waterway	Star of Hope Creek / Adjacent to chainage 72000
Catchment	Belyando and Suttor sub-basin
Waterway Classification	Minor Waterway
Land Use	Moderate grazing
Catchment Area	Approximately 5,538 ha
Stream Order	1
Flow Frequency	Ephemeral

Channel Dimensions	Width of stream channel approximately 8m; width to top of bank approximately 40 m; average bank height approximately 2 m
Bed substrate	Fine gravel/sandy creek with some areas of pebble and cobble.
Channel Sinuosity	Low
Channel Stability	Channel is stable.
Banks	Stable, small riparian zone and medium density bank vegetation.
Instream Features	Trapezoidal channel with in channel islands and pools.
Flow levels	Flood debris observed approximately 2.5 m above low flow channel bed.
Contextual Notes	Moderate erosion; some silt/clay deposition on banks.

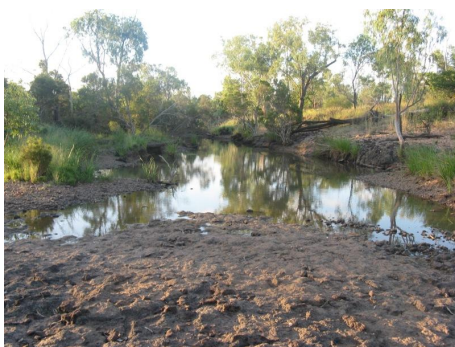
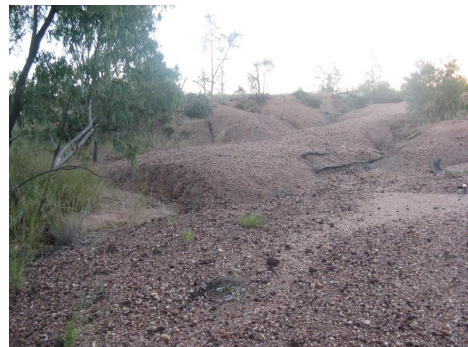
Waterway Crossing – 28

Channel Dimensions	Width of stream channel approximately 30 m; average width to top of bank approximately 50 m; average bank height approximately 3 m
Bed substrate	40% bedrock; 2% cobble; 25% pebble; 30% gravel; 3% sand
Channel Sinuosity	Low
Channel Stability	Channel is stable
Banks	Stable, moderate grass and tree cover, some bare ground, little shrubs
Instream Features	Trapezoidal channel
Flow levels	No flood marks observed
Contextual Notes	Some erosion on banks; little sand/gravel deposition

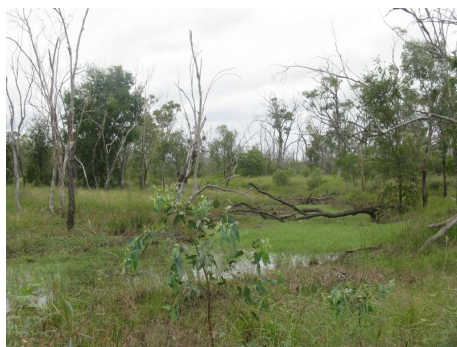
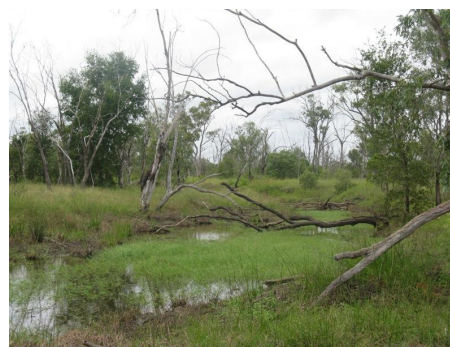
Waterway Crossing – 31

Channel Dimensions	Width of stream channel approximately 5 m; width to top of bank approximately 6 m; bank height approximately 0.5 m
Bed substrate	95% silt/clay; 5% gravel/pebble.
Channel Sinuosity	Medium
Channel Stability	Low
Banks	Extensive grass coverage.
Instream Features	Creek splits downstream of assessment area into three smaller channels
Flow levels	No flood marks observed.
Contextual Notes	Little erosion; little sand deposition.

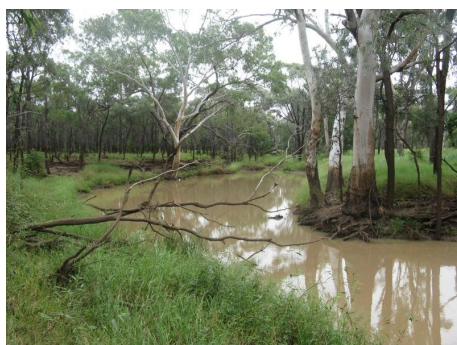
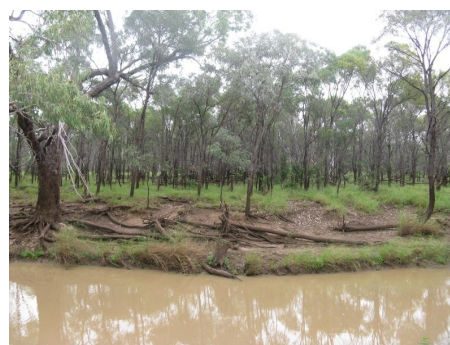
Waterway Crossing –

Channel Dimensions	Width of stream channel approximately 10 m; width to top of bank approximately 15 m; bank height approximately 2 m
Bed substrate	95% silt/clay; 5% sand.
Channel Sinuosity	Medium
Channel Stability	Channel is stable
Banks	Banks contains some areas of bare ground, particularly around tree roots, but predominately grass covered
Instream Features	Highly variable trapezoidal channel
Flow levels	High abundance of flood debris on banks approximately 2 m above water level at assessment date.
Contextual Notes	Little erosion; little sand deposition.

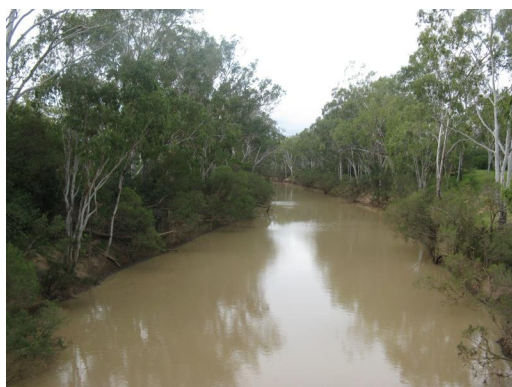
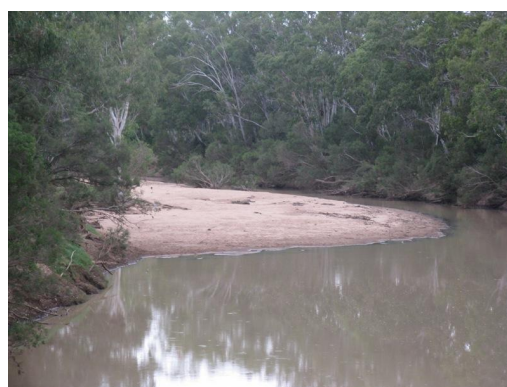
Waterway Crossing – 39

Channel Dimensions	Width of stream channel approximately 25 m; width to top of bank approximately 50 m; bank height approximately 6 m right bank, approximately 12 m left bank
Bed substrate	50% silt/clay; 50% sand
Channel Sinuosity	Medium
Channel Stability	Stable.
Banks	Stable banks, with extensive vegetation, and some erosion signs.
Instream Features	Sand deposits observed downstream at bend where a shallow run is created adjacent
Flow levels	No flood marks observed.
Contextual Notes	Little erosion; moderate silt/clay deposition on banks; sand deposition at bend.

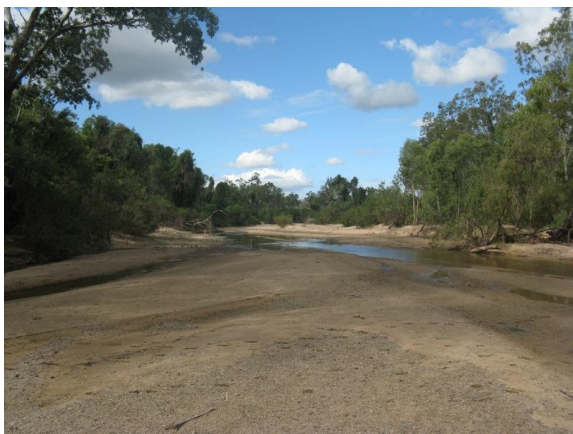
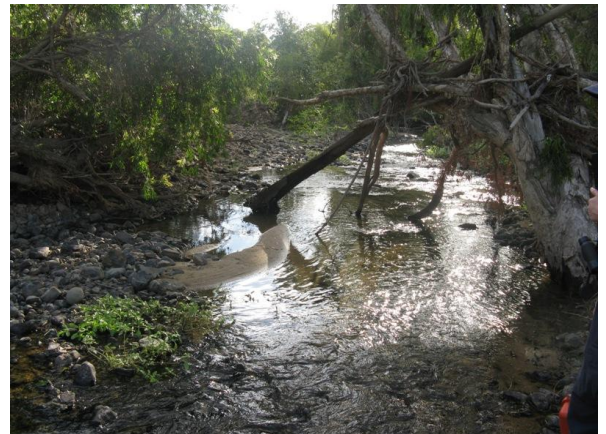
Waterway Crossing – 34

Waterway	Pelican Creek / Chainage 375000
Catchment	Bowen Broken sub-basin
Waterway Classification	Major Waterway
Land Use	Moderate grazing
Catchment Area	approximately 60,683 ha
Stream Order	22
Flow Frequency	Ephemeral
Site Inspection	
Channel Dimensions	Width of stream channel approximately 50 m; width to top of bank approximately 80 m; bank height approximately 4 m left bank, approximately 10 m right bank
Bed substrate	80% gravel; 15% pebble; 5% cobble
Channel Sinuosity	Medium
Channel Stability	Some in channel sinuosity
Banks	Highly stable due to extensive grass cover
Instream Features	Multiple vegetated islands within creek channel
Flow levels	Some debris marks 1,5 m above channel level
Contextual Notes	Erosion and deposition – little

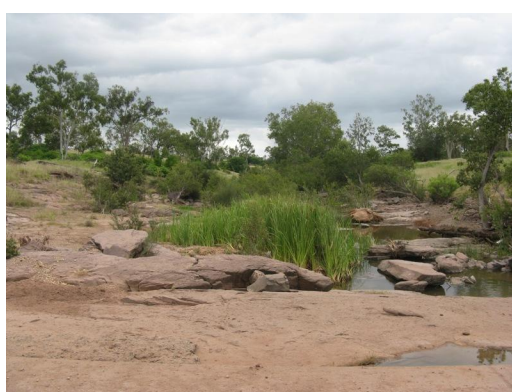
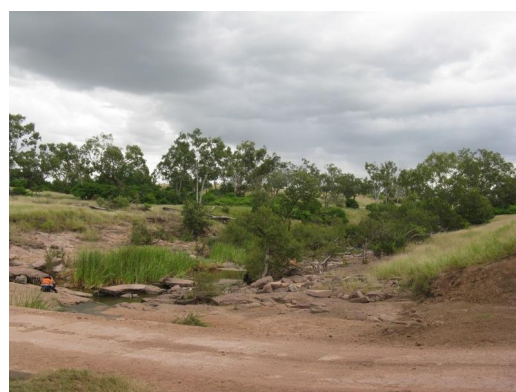
Waterway Crossing – 34

Waterway	Cattle Creek / Adjacent to chainage 380000
Catchment	Bowen Broken sub-basin
Waterway Classification	Minor Waterway
Land Use	Heavy grazing
Catchment Area	N/a (approximately 61,485 ha for whole catchment)
Stream Order	2
Flow Frequency	Ephemeral

Channel Dimensions	Width of stream channel approximately 3 m; width to top of bank approximately 12 m; bank height approximately 4 m left bank, approximately 2 m right bank
Bed substrate	80% gravel; 10% pebble; 10% sand
Channel Sinuosity	Medium
Channel Stability	High
Banks	Stable due to extensive grass cover
Instream Features	Stream splits into small channels
Flow levels	Some debris marks approximately 1 m above channel level
Contextual Notes	Likely to only flow during flooding

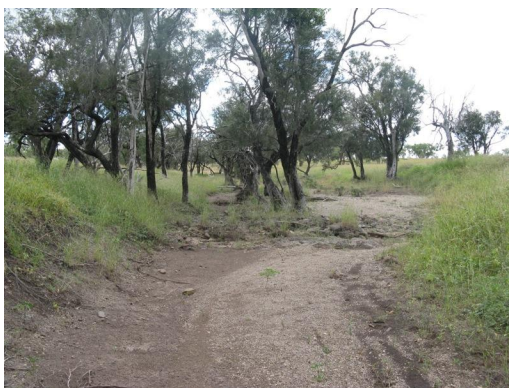
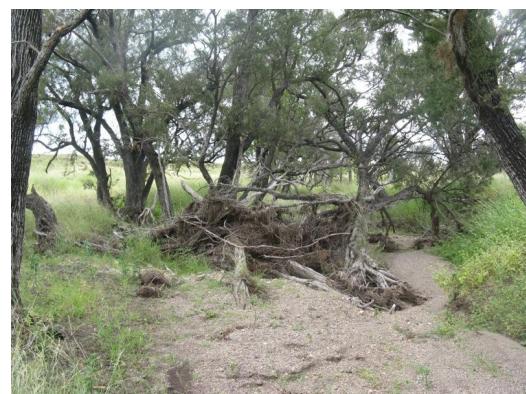
Waterway Crossing – 29

Waterway	King Creek / Adjacent to chainage 410000
Catchment	Lower Burdekin sub-basin
Waterway Classification	Minor Waterway
Land Use	Moderate grazing
Catchment Area	Approximately 5,276 ha
Stream Order	1
Flow Frequency	Ephemeral

Channel Dimensions	Width of stream channel approximately 6 m low flow channel, 8 m high flow channel; width to top of bank approximately 35 m; bank height approximately 5 m
Bed substrate	70% gravel; 20% pebble; 10% cobble
Channel Sinuosity	Medium
Channel Stability	Stable
Banks	Stable due to good grass cover
Instream Features	Some pool and island forming
Flow levels	Debris marks approximately 3 meters above water level at site visit
Contextual Notes	Little erosion; little deposition in high flow channel

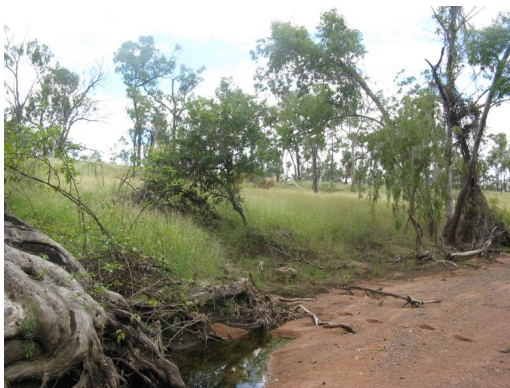
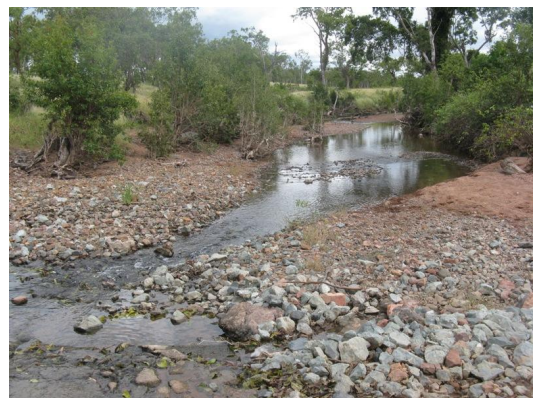
Waterway Crossing – 31

Waterway	Herbert Creek
Catchment	Lower Burdekin sub-basin
Waterway Classification	Minor waterway
Land Use	Moderate grazing
Catchment Area	approximately 6,188 ha
Stream Order	1
Flow Frequency	Ephemeral

Channel Dimensions	Width of stream channel approximately 4 m; width to top of bank approximately 6 m; bank height approximately 3 m left bank, approximately 4 m right bank
Bed substrate	60% gravel; 38% pebble; 2% bedrock
Channel Sinuosity	Low
Channel Stability	High
Banks	Stable due to high vegetation density
Instream Features	Variable trapezoidal channel
Flow levels	Debris marks approximately 2 meter above channel
Contextual Notes	Little erosion; little deposition

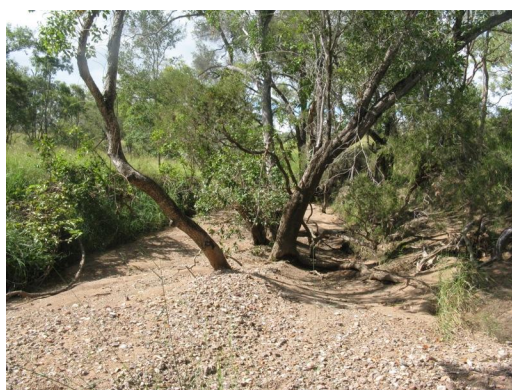
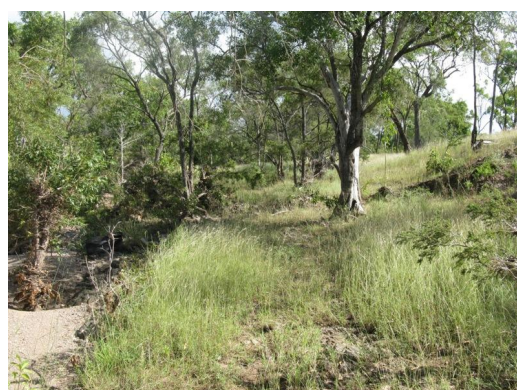
Waterway Crossing – 32

Waterway	Capsize Creek
Catchment	Lower Burdekin sub-basin
Waterway Classification	Minor Waterway
Land Use	Moderate grazing
Catchment Area	Approximately 11,590 ha
Stream Order	1
Flow Frequency	Ephemeral

Channel Dimensions	Width of stream channel approximately 4 m; width to top of bank approximately 10 m; bank height approximately 3 m left bank, approximately 5 m right bank;
Bed substrate	75% gravel; 20% pebble; 5% cobble
Channel Sinuosity	Low
Channel Stability	High
Banks	Stable due to good vegetation cover
Instream Features	Pools, steep left bank, some erosion due to cattle entering
Flow levels	Debris marks approximately 3 meter above channel
Contextual Notes	Little erosion; some fine gravel deposition

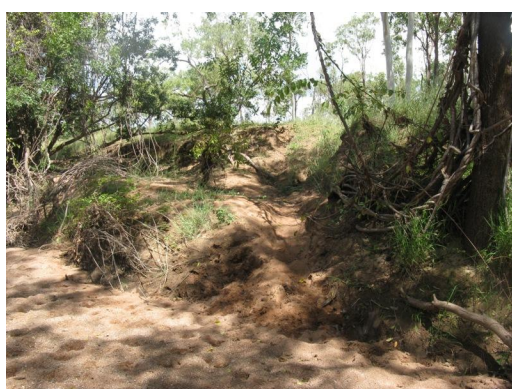
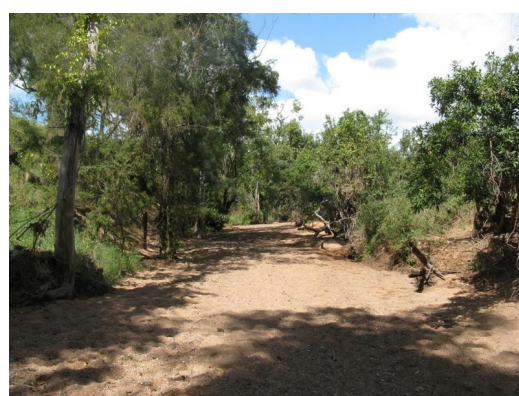
Waterway Crossing – 37

Waterway	Bogie River / Adjacent to chainage 430000
Catchment	Lower Burdekin sub-basin
Waterway Classification	Major Waterway
Land Use	Moderate grazing
Catchment Area	Approximately 101,872 ha
Stream Order	12
Flow Frequency	Ephemeral

Channel Dimensions	Width of stream channel approximately 100 m; width to top of bank approximately 150 m; bank height approximately 10 m right bank, approximately 12 m left bank
Bed substrate	90% fine sandy gravel; 10% boulder, cobble and pebble
Channel Sinuosity	High
Channel Stability	Low
Banks	Stable due to good vegetation cover
Instream Features	Island forming, much channel diversion
Flow levels	No flood marks observed
Contextual Notes	Little erosion and deposition

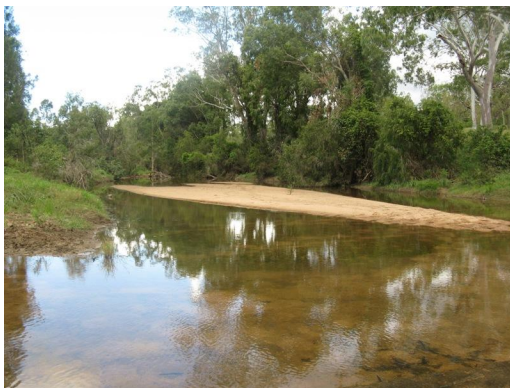
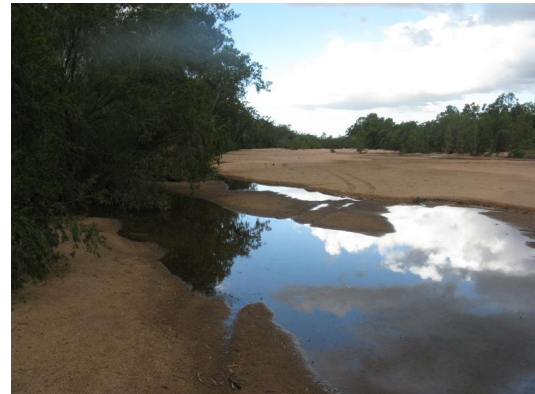
Waterway Crossing – 37

Waterway	Brigalow Creek / Chainage 437000
Catchment	Lower Burdekin sub-basin
Waterway Classification	Minor Waterway
Land Use	Moderate grazing
Catchment Area	N/a (part of Bogie River catchment)
Stream Order	n/a
Flow Frequency	Ephemeral

Channel Dimensions	Width of stream channel approximately 5 m; width to top of bank approximately 7 m; bank height approximately 1 m left bank, approximately 0.5 m right bank
Bed substrate	50% sand; 50% gravel
Channel Sinuosity	Low
Channel Stability	High
Banks	Stable due to good vegetation cover
Instream Features	Some pools.
Flow levels	No flood marks observed
Contextual Notes	Little sand deposition

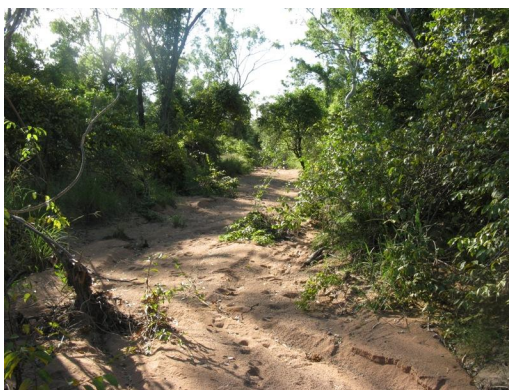
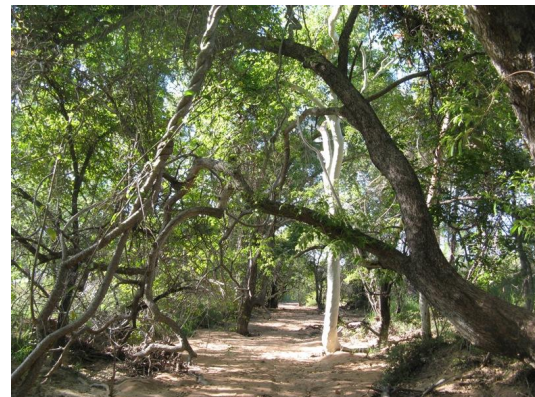
Waterway Crossing – 54

Waterway	Elliot River / Adjacent to chainage 471000
Catchment	Don River basin
Waterway Classification	Major Waterway
Land Use	Moderate grazing
Catchment Area	Approximately 15,154 ha
Stream Order	2
Flow Frequency	Ephemeral

Channel Dimensions	Width of stream channel approximately 25 m; width to top of bank approximately 100 m; bank height approximately 15 m right bank, approximately 10 m left bank
Bed substrate	80% gravel; 10% pebble; 10% sand
Channel Sinuosity	Medium
Channel Stability	Medium
Banks	Stable
Instream Features	High and low flow channels
Flow levels	Debris marks approximately 2 meter above channel
Contextual Notes	Little erosion; deposition – sand

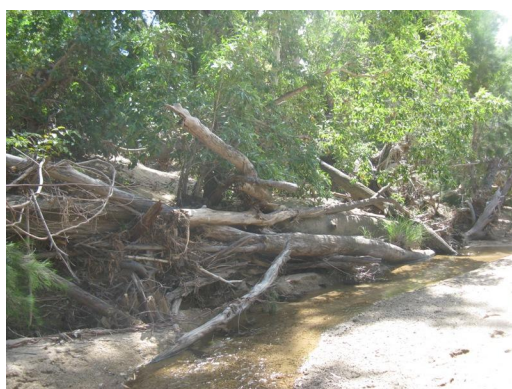
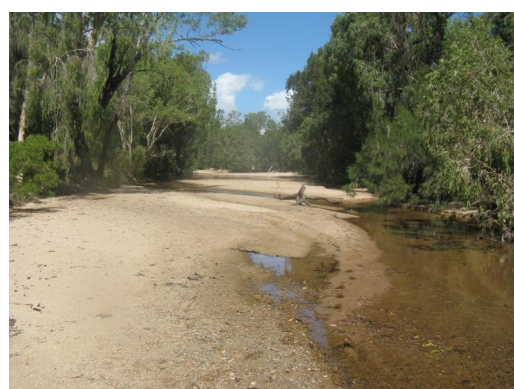
Waterway Crossing – 57

Waterway	Splitters Creek / Chainage 483000
Catchment	Don River Basin
Waterway Classification	Minor Waterway
Land Use	Moderate grazing
Catchment Area	Approximately 6,139 ha
Stream Order	2
Flow Frequency	Continuous

Channel Dimensions	Width of stream channel approximately 6 m; width to top of bank approximately 25 m; bank height approximately 4 m left bank, approximately 6 m right bank
Bed substrate	90% sand; 5% gravel; 5% pebble
Channel Sinuosity	High
Channel Stability	High
Banks	Stable due to good vegetation cover
Instream Features	None
Flow levels	Debris marks up till approximately 4 meters above channel
Contextual Notes	Little erosion on upper bank; some sand deposition on banks
