Soil and Land Suitability Assessment

Kevin's Corner

Kevin's Corner Project Environmental Impact Statement

Soil & Land Suitability Assessment

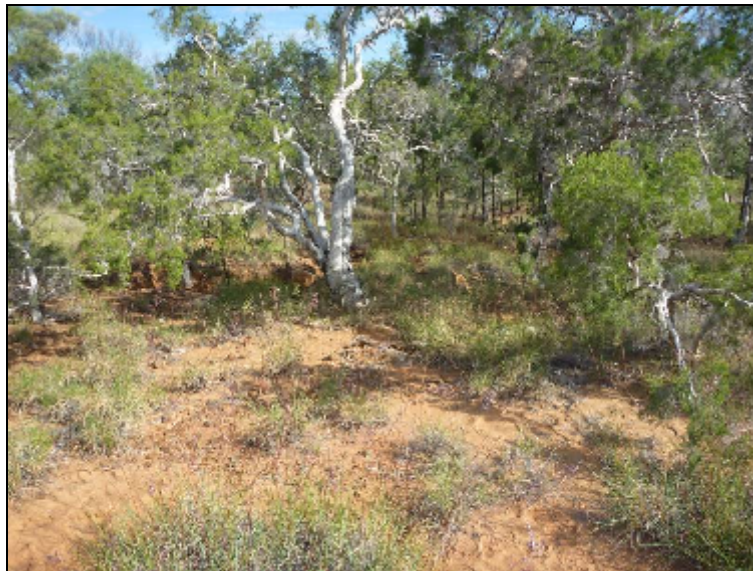
Plate 1: Cudmore Land System (CE2)

The Cudmore land system contains some of the most rugged, inaccessible country in the Desert Uplands bioregion (Plate 1). The soil-vegetation associations are quite diverse with dense heathlands of slender wattle, fringe myrtle and desert tea-tree on shallow uniform sands over an ironstone hardpan (CE1), dense woodlands of lancewood on steep scarps with exposed ferricrete and gradational soils of variable depth (CE2), and complex woodlands of lancewood, narrow-leaved ironbark and bloodwood on moderate - steep slopes derived from sandstone with texture contrast soils with shallow topsoils covered with a mantle of silcrete (CE3). On the gentle lower slopes a complex of reddish-brown gradational and texture-contrast profiles plus some brown uniform clay soils support tall woodlands of silver-leaved ironbark and poplar box with some lemon-scented gum and Gympie messmate, and mid-high woodlands of brigalow, respectively (CE4). A tall woodland of river red gum predominates on the alluvial silty loam profiles of the stream banks and adjacent alluvial areas (CE5).

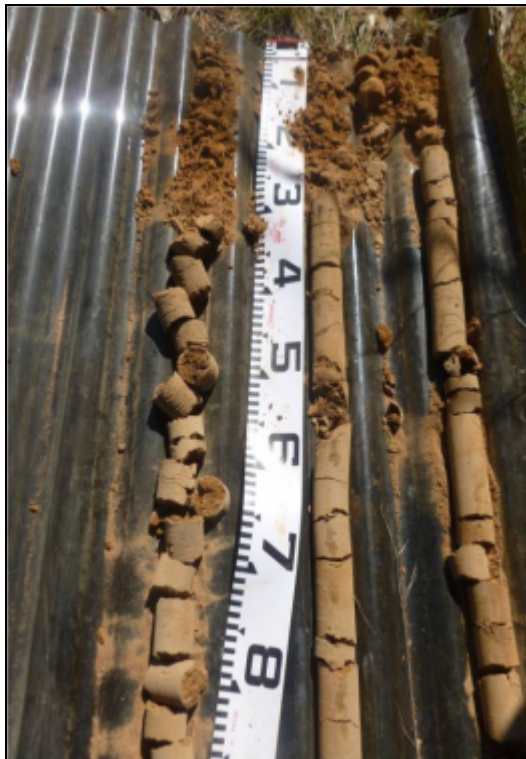
Plate 1.1: CE1 - Brown Sodosol

Soil Description; The Brown Sodosol observed at Site 69 is a texture contrast soil that generally consists of brown loamy sand overlying reddish brown clay loam to clay. A bleached A2 horizon lies between the topsoil and the subsoil. These well drained topsoils and poorly drained subsoils have a neutral pH, are non saline with low fertility characteristics. The subsoil is strongly sodic. Structure is moderate with 5 to 15mm sub angular blocky peds through to strong 2 to 20mm smooth faced angular blocky structure down the profile. The analytical information of the representative site is presented in **Figure CE1 - A** and **Table 3** below.

Management; Generally the topsoil does not display any specific management risk related to potential disturbance during stripping. The topsoil layer exhibits structure and chemical characteristics that would be suitable as surface cover in rehabilitation. The subsoil not recommended for stripping given it is strongly sodic and would require erosion control structures to be implemented if disturbed. The recommended stripping depth of this soil is 0.25 m.

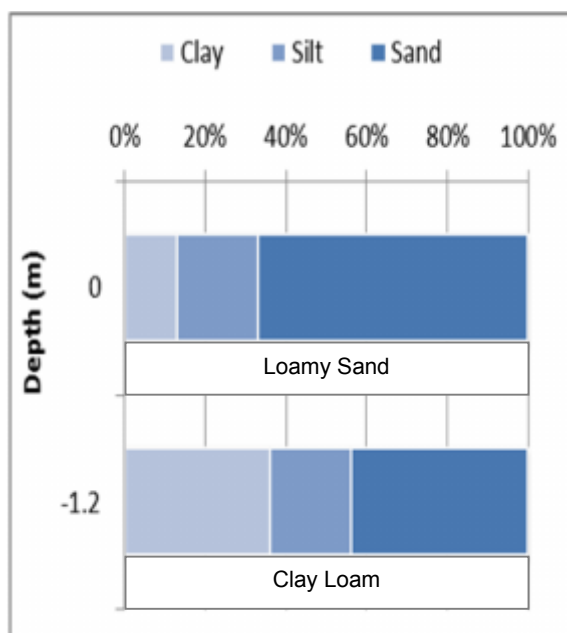
Figure CE1 - B: Particle Size Analysis

Figure CE1 - B shows the soil texture throughout the profile, and **Figure CE1 - C** shows the trend of exchangeable cations with depth. The full suite of analytical results for this soil type can be found in **Appendix 3**.

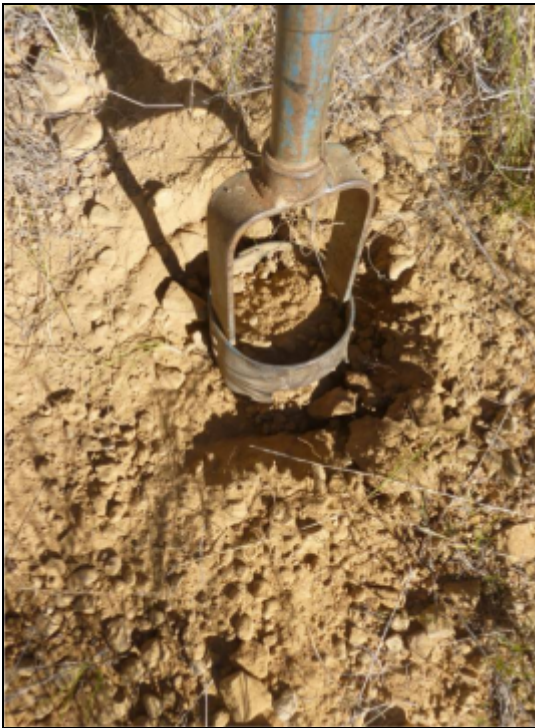
Plate 1.2: CE2 - Petroferic Rudosol

Soil Description; There is no soil profile information or lab analysis for this land unit given the rocky nature of the surface and restricted access during fieldwork, however the following information applies to the land unit: The steep, rocky nature of this land unit and the very high susceptibility to erosion, restrict the options for alternative land use and limit the level of productivity. The soils are shallow, droughty and of low fertility. The land surface is subject to high runoff. The ground cover has a low productivity and is vulnerable to overgrazing and degradation and it is difficult to regenerate. Laboratory analysis was not undertaken for this soil type. The above description is based on field observations.

Management; Generally this soil is unsuitable for use in rehabilitation due to its rocky nature.

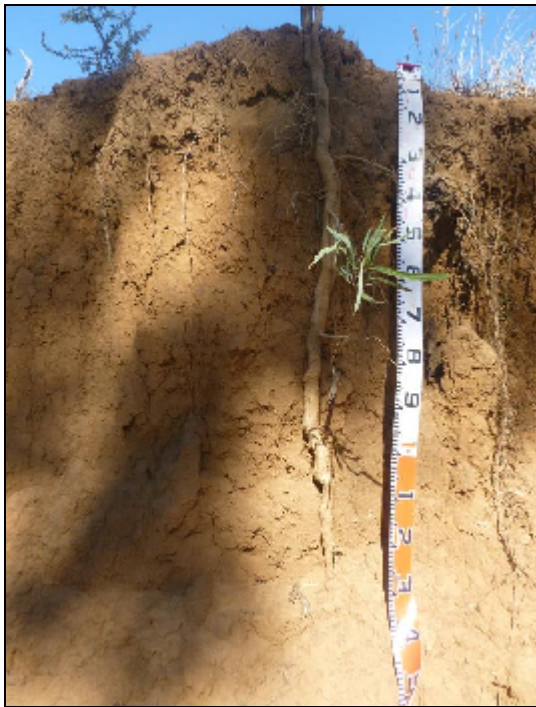
Plate 1.3: CE3 - Browns Sodosol

Soil Description; The Brown Sodosol observed at Site 71 is a texture contrast soil that generally consists of light brown sandy loam overlying reddish brown clay. These moderately drained topsoils and poorly drained soils have moderate structure with 5 to 15mm platy peds through to moderate 20 to 50mm rough faced angular blocky structure down the profile. Laboratory analysis was not undertaken for this soil type. The above description is based on field observations, however the following information applies to the land unit: Erosion is a natural process and quite active in this land unit, however, increased grazing pressure is likely to reduce the sparse ground cover even further and increase the rate of erosion. The soils are shallow, droughty and of low fertility. The land surface is subject to high runoff. The ground cover has a low productivity and is vulnerable to overgrazing and degradation, which is difficult to regenerate.

Management; Generally the topsoil does not display any specific management risk related to potential disturbance during stripping. The topsoil layer exhibits structural characteristics that would be suitable as surface cover in rehabilitation. The subsoil appears sodic and would require erosion control structures to be implemented if disturbed. The recommended stripping depth of this soil is 0.15 m.

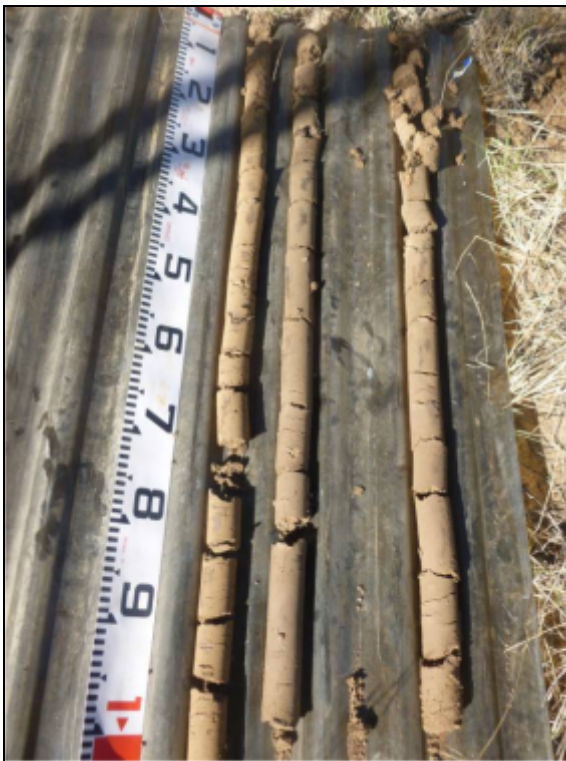
Plate 1.4: CE4 – Brown Vertosol

Soil Description; The Brown Vertosol observed at Site 61 is a uniform textured soil that generally consists of brown to reddish brown silty clay throughout the profile. These poorly drained soils have a neutral pH, are highly saline below 0.05m with high fertility characteristics. The soil below 0.05m is strongly sodic. Structure is moderate to strong throughout the profile. The analytical information of the representative site is presented in **Figure CE4 - A** and **Table 4** below.

Management; Generally these soils are not suitable for stripping due to the high salinity and strong sodicity below 0.05m. The top 0.05m may be salvaged and blended with sandy material to create a suitable medium for the re-establishment of vegetation. Therefore if required this soil may be stripped to 0.05m however the exposed soil would require erosion control structures to be implemented. The recommended stripping depth of this soil is 0.05 m if treated.

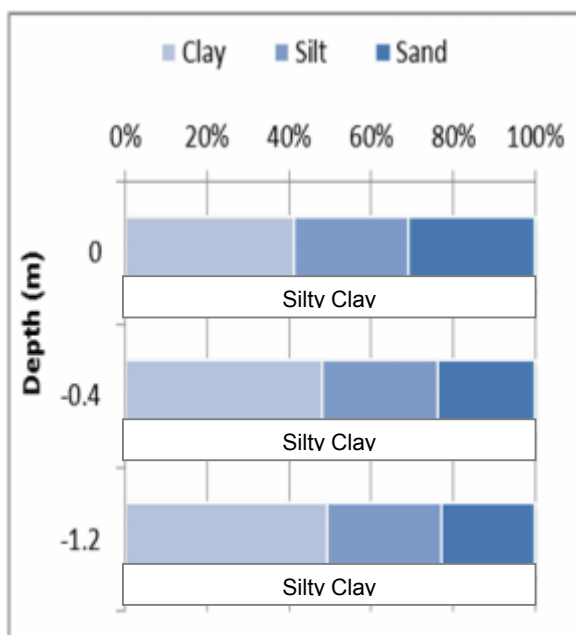
Figure CE4 - B: Particle Size Analysis

Figure CE4 - B shows the soil texture throughout the profile, and **Figure CE4 - C** shows the trend of exchangeable cations with depth. The full suite of analytical results for this soil type can be found in **Appendix 3**.

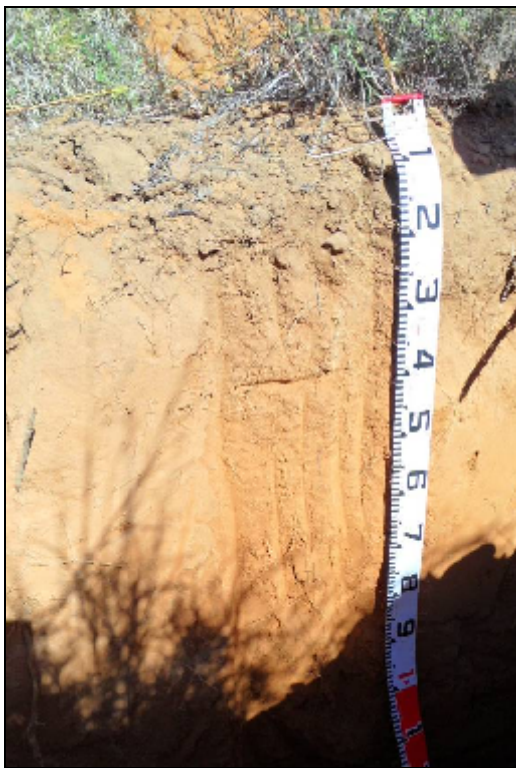
Plate 1.5: CE5 – Rudosol

Soil Description; The Rudosol observed at Site 4 is a uniform textured soil that generally consists of light brown to reddish brown loamy sand to sand throughout the profile. These well drained soils are mildly alkaline, non saline with very low fertility characteristics. The soil is non sodic and structure is weak throughout the profile. The analytical information of the representative site is presented in **Figure CE5 - A** and **Table 5** below.

Management; Generally the soil does not display any specific management risk related to potential disturbance during stripping. The soil is marginally suitable for use in rehabilitation and would benefit by blending with a clay material to improve the water holding capacity. The recommended stripping depth of this soil is 1.2 m, providing it is blended with clay material.

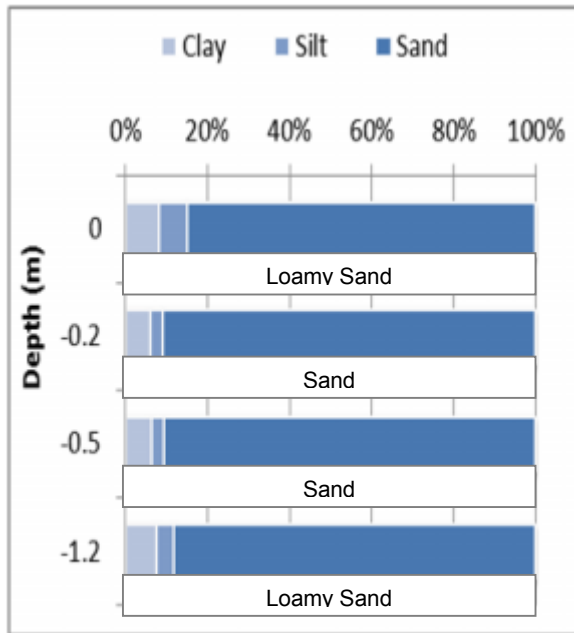
Figure CE5 - B: Particle Size Analysis

Figure CE5 - B shows the soil texture throughout the profile, and **Figure CE5 - C** shows the trend of exchangeable cations with depth. The full suite of analytical results for this soil type can be found in **Appendix 3**.

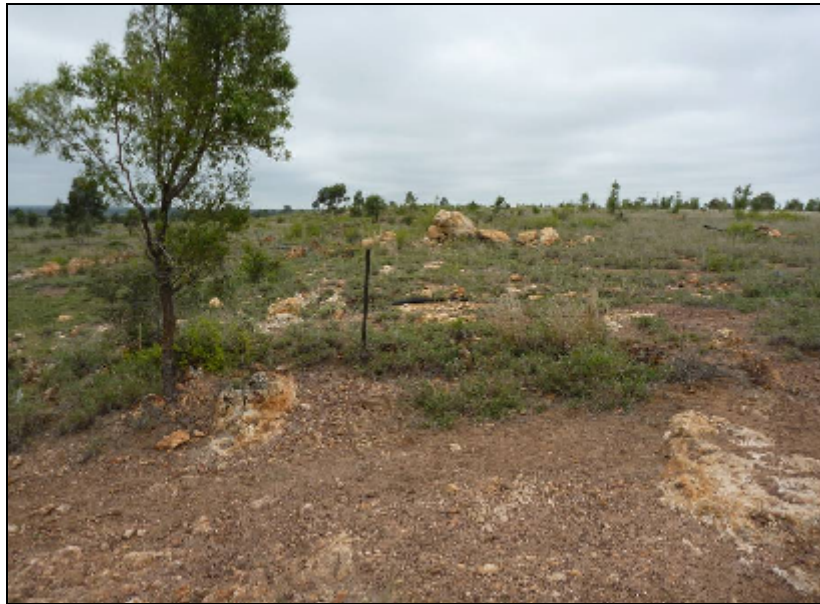
Plate 2: Colorado Land System (CO2)

The Colorado land system represents an extensive area of steeply dissected country in the western half of the Study Area. The plateau margin (CO1) with sandy gradational soils overlying an ironstone hardpan, sometimes exposed at the surface, supports a shrubland with isolated Normanton box, ghost gum and bloodwood. The scarp (CO2) of exposed ferricrete has variable steepness and soil depth, but lancewood and bendee dominate the vegetation. The footslopes (CO3) have open woodlands of silver-leaved ironbark, poplar box and ghost gum with diverse shrub and ground cover layers on deep texture-contrast soil profiles.

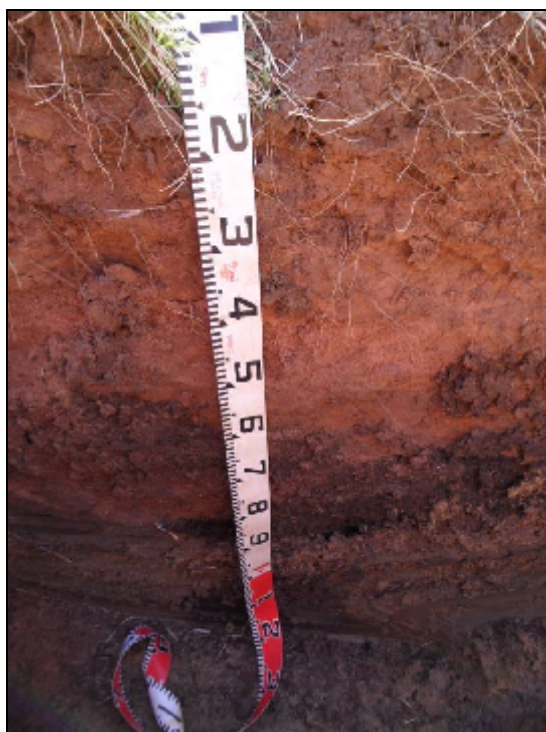
Plate 2.1: C02 – Brown Kandosol

Soil Description; The Brown Kandosol observed at Site 23 is a gradational textured soil that generally consists of brown to reddish brown silty loam to silty clay loam down the profile. These moderately drained soils have a slightly acidic to neutral pH, are non saline, non sodic with very low fertility characteristics. Structure is moderate platy to sub angular blocky down the profile. The analytical information of the representative site is presented in **Figure C02 - A** and **Table 6** below.

Management; Generally these soils do not display any specific management risk related to potential disturbance during stripping. The soil exhibits structure and chemical characteristics that would be suitable as surface cover in rehabilitation. The recommended stripping depth of this soil is 1.2 m.

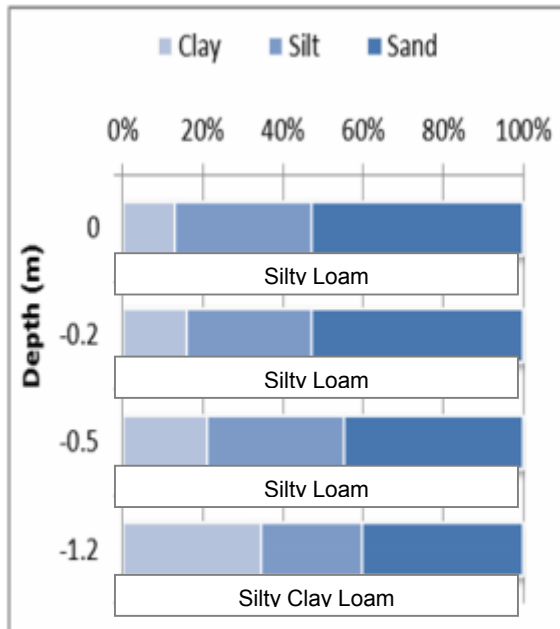
Figure C02 - B: Particle Size Analysis

Figure CO2 - B shows the soil texture throughout the profile, and **Figure CO2 - C** shows the trend of exchangeable cations with depth. The full suite of analytical results for this soil type can be found in **Appendix 3**.

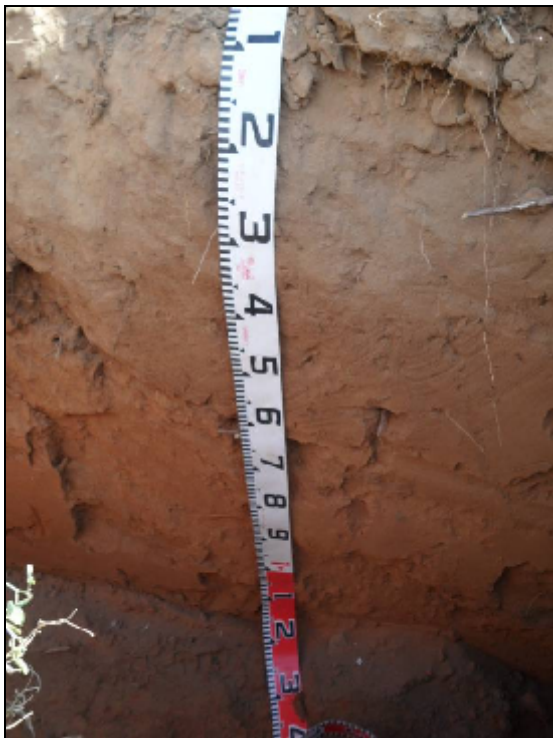
Plate 2.2: C03 – Rudosol

Soil Description; The Rudosol observed at Site 8 is a uniform textured soil that generally consists of grey brown to red loamy sand throughout the profile. These well drained soils are slightly acidic, non saline, non sodic with very low fertility characteristics. Structure is weak throughout the profile. The analytical information of the representative site is presented in **Figure CO3 - A** and **Table 7** below.

Management; Generally the soil does not display any specific management risk related to potential disturbance during stripping. The soil is marginally suitable for use in rehabilitation and would benefit by blending with a clay material to improve the water holding capacity. The recommended stripping depth of this soil is 1.2 m, providing it is mixed with clay material.

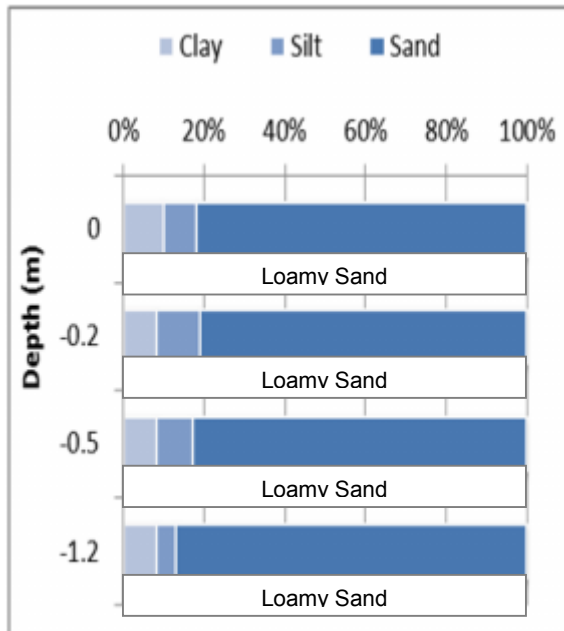
Figure CO3 - B: Particle Size Analysis

Figure CO3 - B shows the soil texture throughout the profile, and **Figure CO3 - C** shows the trend of exchangeable cations with depth. The full suite of analytical results for this soil type can be found in **Appendix 3**.

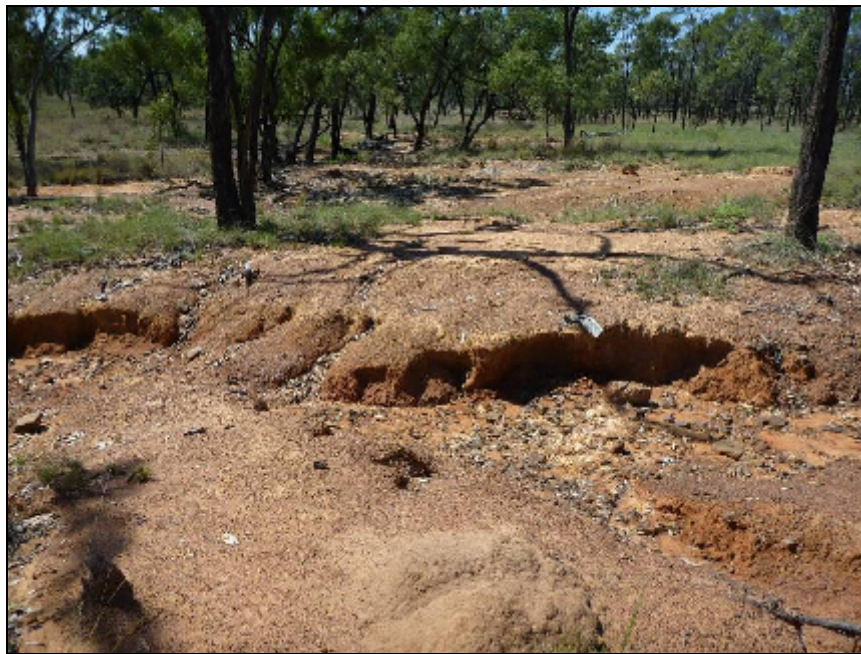
Plate 3: Southern Plateau Land System (SP1)

The Southern Plateau land system represents an extensive landscape of undulating rises to the east of the lateritic Cudmore LS. An ironstone hardpan underlies most of the area and has a profound influence on the vegetation of the crests and upper slopes (SP1), where sparse woodlands of silver-leaved ironbark and ghost gum, together with occasional applejack and bush-house paperbark exist on shallow uniform sands and sandy loams. White cypress pine and poplar box are not uncommon, but represent small areas with deeper soil profiles. On the lower slopes (SP2) deep texture-contrast soil profiles predominate with thick sandy loam topsoils and reddish brown clay subsoils. Tall sparse woodlands consist of silver-leaved ironbark and ghost gum with a mid stratum of ironwood, false sandalwood, prickly pine, quinine tree and dead finish. Gummy spinifex dominates the ground layer. The drainage depressions with young sandy soils of variable depth and river red gum have been combined with closed depressions, which have grey uniform clay soils and coolabah-gidgee vegetation, to form land unit SP3. These areas are minor in extent but have important conservation values as riparian corridors and ephemeral wetlands.

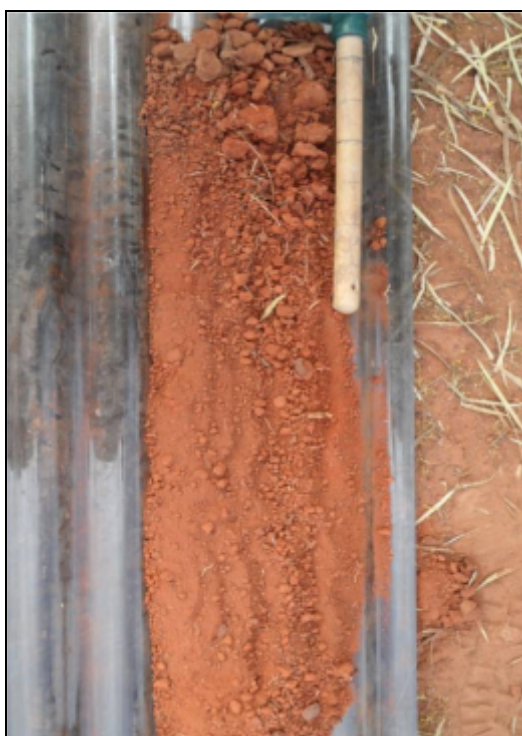
Plate 3.1: SP1a – Red Dermosol

Soil Description; The Red Dermosol observed at Site 97 is a uniform textured soil that generally consists of red brown to red silty clay loam throughout the profile. These well drained soils are strongly acidic, non saline, non sodic with very low fertility characteristics. Structure is strong in the topsoil and weak in the subsoil. The analytical information of the representative site is presented in **Figure SP1a - A** and **Table 8** below.

Management; Although the soil is strongly acidic, lime can be applied to ensure there is minimal management risks related to potential disturbance during stripping. The soil is marginal to not suitable given the poor structure and high acidity, as a surface cover in rehabilitation, and acid tolerant species may be required.

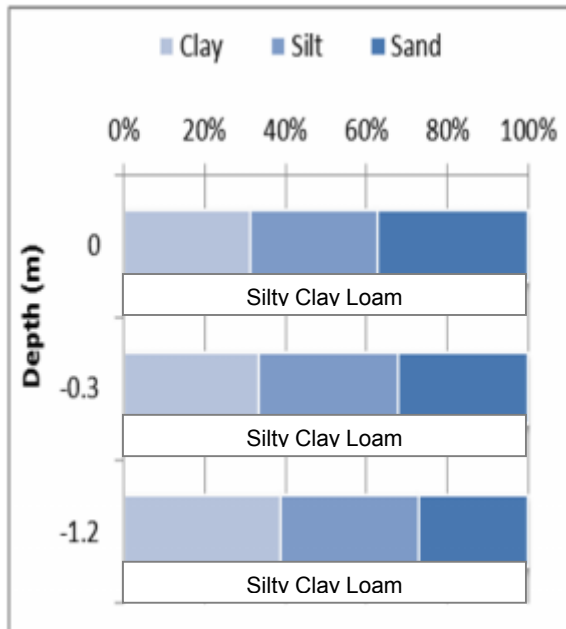
Figure SP1a - B: Particle Size Analysis

Figure SP1a - B shows the soil texture throughout the profile, and **Figure SP1a - B** shows the trend of exchangeable cations with depth. The full suite of analytical results for this soil type can be found in **Appendix 3**.

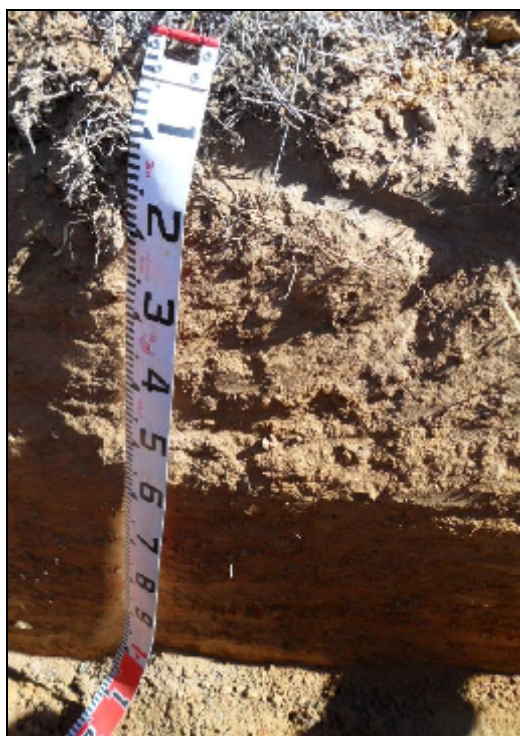
Plate 3.2: SP1b – Yellow Kandosol

Soil Description; The Yellow Kandosol observed at Site 1 is a gradational textured soil that generally consists of brown to pale yellow loam to bright yellow clay loam down the profile. These moderate to poorly drained soils are moderate to slightly acidic, non saline, non sodic with very low fertility characteristics. Structure is moderate platy to sub angular blocky down the profile. The analytical information of the representative site is presented in **Figure SP1b - A** and **Table 9** below.

Management; Generally these soils do not display any specific management risk related to potential disturbance during stripping. The soil exhibits structure and chemical characteristics that would be suitable as surface cover in rehabilitation. The recommended stripping depth of this soil is 1.2 m.

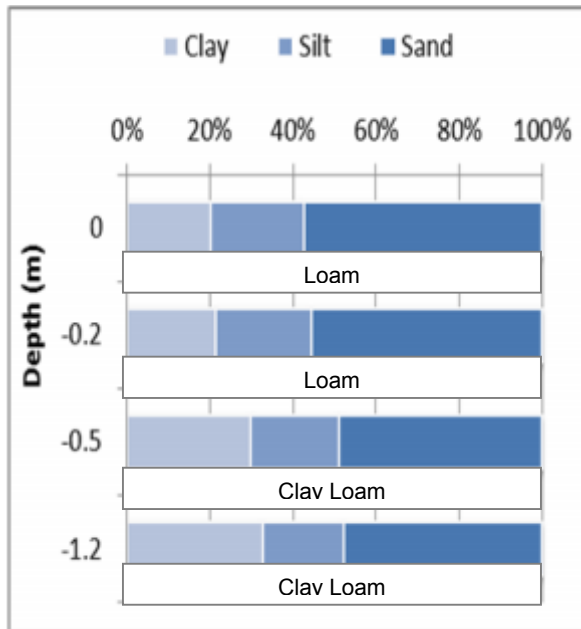
Figure SP1b - B: Particle Size Analysis

Figure SP1b - B shows the soil texture throughout the profile, and **Figure SP1b - C** shows the trend of exchangeable cations with depth. The full suite of analytical results for this soil type can be found in **Appendix 3**.

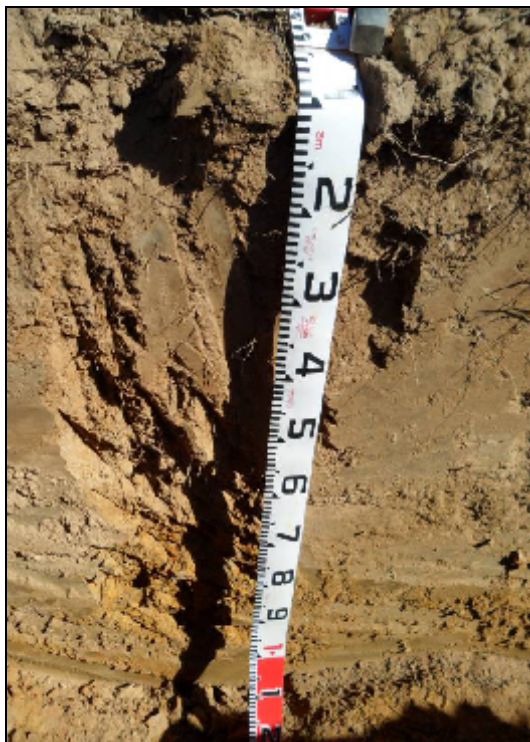
Plate 3.3: SP1c – Yellow Sodosol

Soil Description; The Yellow Sodosol observed at Site 3 is a texture contrast soil that generally consists of grey brown to yellow loam overlying yellow clay. These moderately drained topsoils have weak to moderate structure, are moderately acidic, non saline, non sodic with very low fertility characteristics. The poorly drained subsoils have weak to massive structure, are slightly alkaline, non saline, strongly sodic and have low fertility characteristics. The analytical information of the representative site is presented in **Figure SP1c - A** and **Table 10** below.

Management; Generally the topsoil does not display any specific management risk related to potential disturbance during stripping. The topsoil layer exhibits structural characteristics that would be suitable as surface cover in rehabilitation. The subsoil is sodic and would require erosion control structures to be implemented if disturbed. The recommended stripping depth of this soil is 0.6 m.

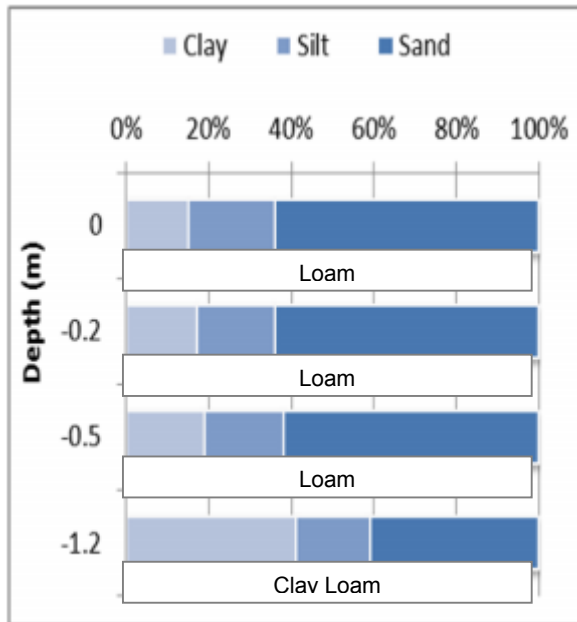
Figure SP1c - B: Particle Size Analysis

Figure SP1c - B shows the soil texture throughout the profile, and **SP1c - C** shows the trend of exchangeable cations with depth. The full suite of analytical results for this soil type can be found in **Appendix 3**.

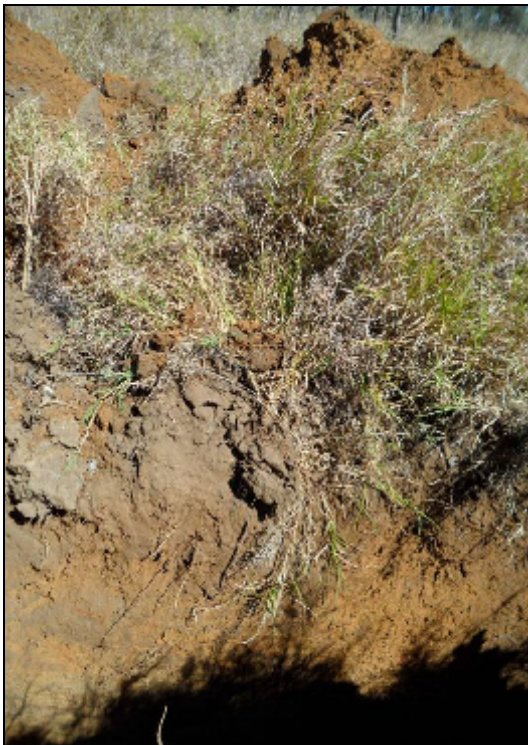
Plate 3.4: SP2a – Red Sodosol

Soil Description; The Red Sodosol observed at Site 30 is a texture contrast soil that generally consists of brown silty loam overlying red silty clay loam. These well drained topsoils have moderate structure, neutral pH, are non saline, non sodic with very low fertility characteristics. The poorly drained subsoils have moderate structure, are moderate to strongly alkaline, moderate to highly saline, strongly sodic and have moderate fertility characteristics. The analytical information of the representative site is presented in **Figure SP2a - A** and **Table 11** below.

Management; Generally the topsoil does not display any specific management risk related to potential disturbance during stripping. The topsoil layer exhibits structural characteristics that would be suitable as surface cover in rehabilitation. The subsoil is strongly sodic and saline and would require erosion control structures to be implemented if disturbed. The recommended stripping depth of this soil is 0.3 m.

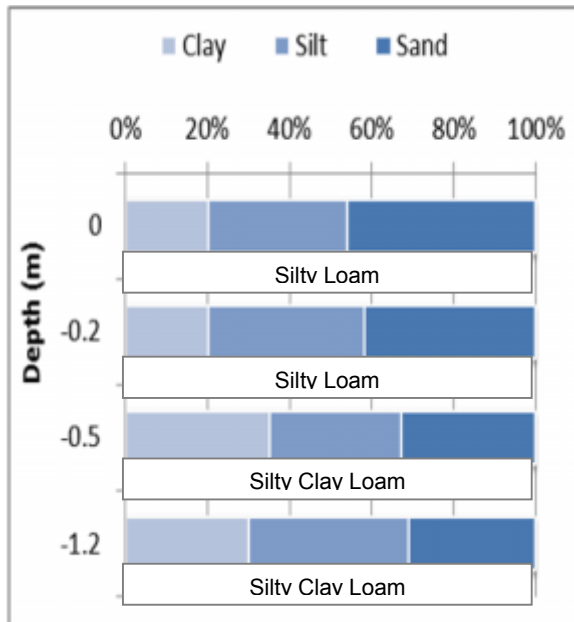
Figure SP2a - B: Particle Size Analysis

Figure SP2a - B shows the soil texture throughout the profile, and **Figure SP2a - C** shows the trend of exchangeable cations with depth. The full suite of analytical results for this soil type can be found in **Appendix 3**.

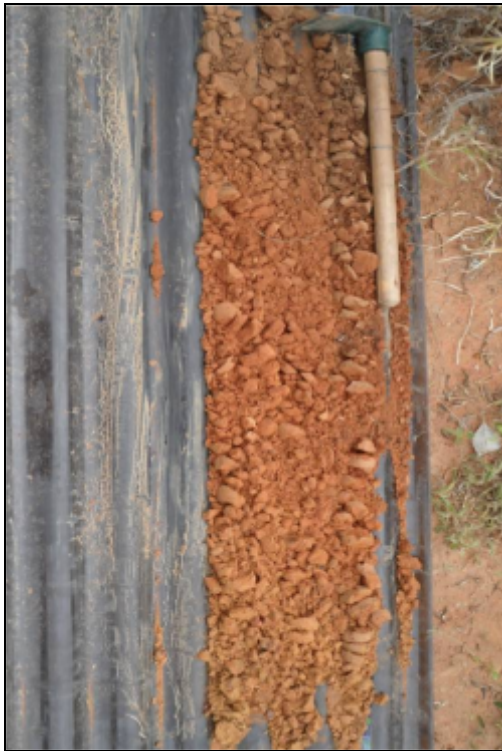
Plate 3.5: SP2b – Brown Dermosol

Soil Description; The Brown Dermosol observed at Site 21 is a uniform textured soil that generally consists of brown to red brown loam through to yellow brown silty loam down the profile. These well drained soils are slightly acidic to neutral, non saline, non sodic with low fertility characteristics. Structure is moderate to weak in the top layers, through to strong in the subsoil. The analytical information of the representative site is presented in **Figure SP2b - A** and **Table 12** below.

Management; Generally these soils do not display any specific management risk related to potential disturbance during stripping. The soil exhibits structure and chemical characteristics that would be suitable as surface cover in rehabilitation. The recommended stripping depth of this soil is 1.2 m.

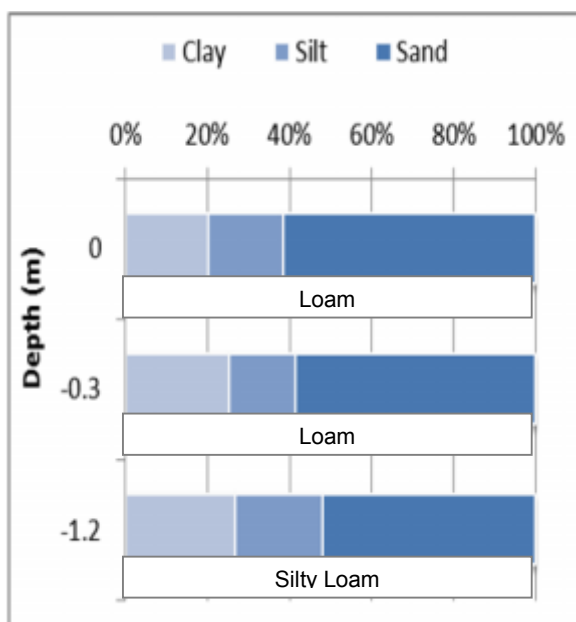
Figure SP2b - B: Particle Size Analysis

Figure SP2b - B shows the soil texture throughout the profile, and **Figure SP2b - C** shows the trend of exchangeable cations with depth. The full suite of analytical results for this soil type can be found in **Appendix 3**.

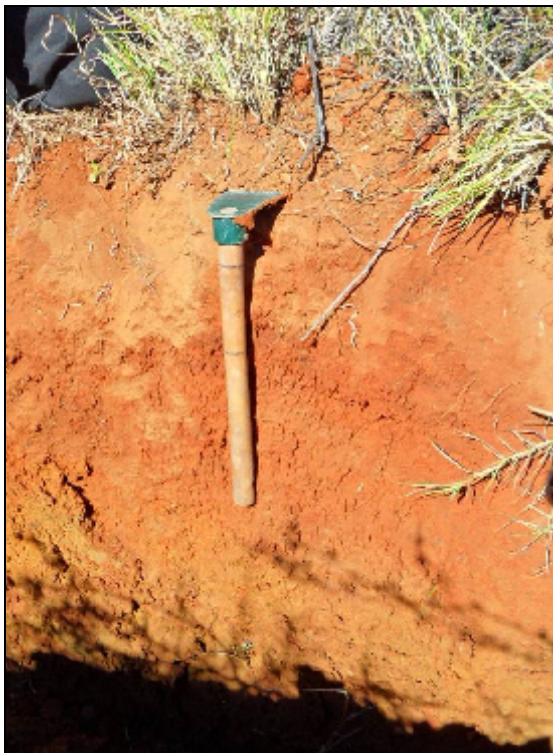
Plate 3.6: SP3 – Red Sodic Dermosol

Soil Description; The Red Sodic Dermosol observed at Site 16 is a gradational textured soil that generally consists of reddish brown to red silty loam through to mottled yellow clay loam down the profile. These well drained soils are slightly neutral to moderately alkaline, non saline, non sodic to strongly sodic in the lower layer, with very low to low fertility characteristics. Structure is strong to moderate down the profile. The analytical information of the representative site is presented in **Figure SP3 - A** and **Table 13** below.

Management; Generally the topsoil does not display any specific management risk related to potential disturbance during stripping. The topsoil layer exhibits structural characteristics that would be suitable as surface cover in rehabilitation. The subsoil is strongly sodic and would require erosion control structures to be implemented if disturbed. The recommended stripping depth of this soil is 0.3 m.

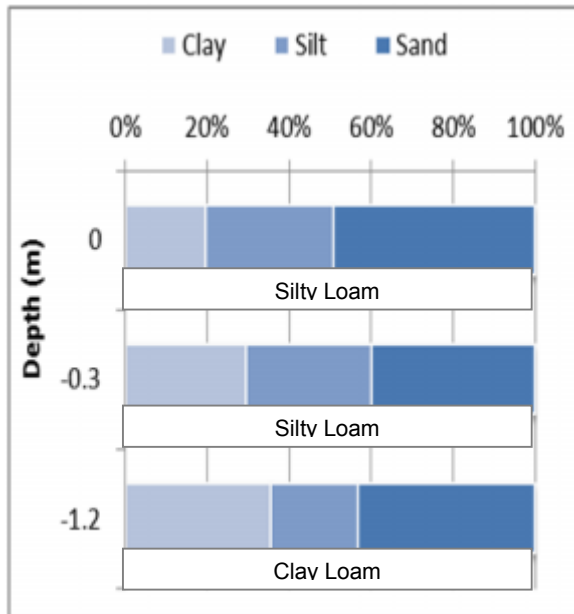
Figure SP3 - B: Particle Size Analysis

Figure SP3 - B shows the soil texture throughout the profile, and **Figure SP3 - C** shows the trend of exchangeable cations with depth. The full suite of analytical results for this soil type can be found in **Appendix 3**.

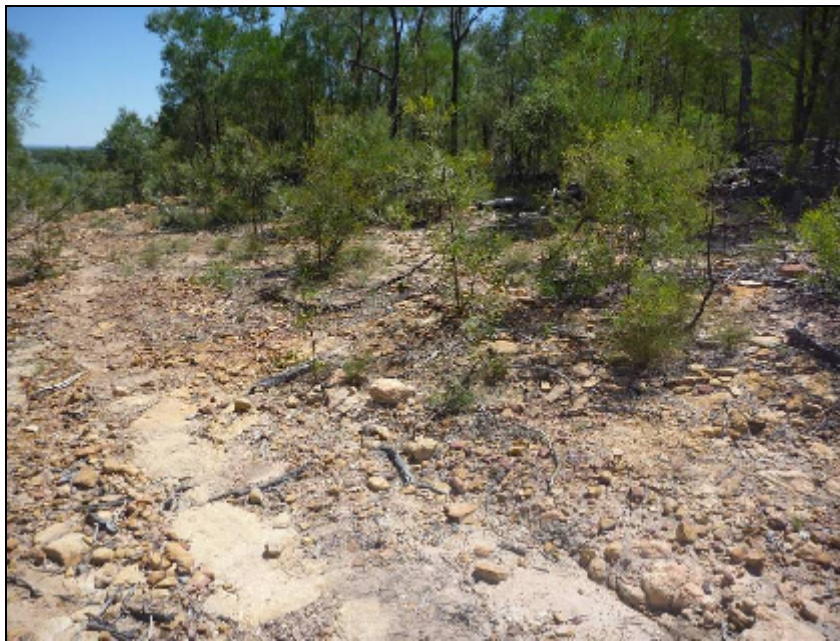
Plate 4: Joe Joe Land System (JJ2)

The Joe Joe land system represents a prominent ridge of sandstones on the eastern side of the lease. The crests and upper slopes have open woodlands dominated by silver-leaved ironbark on moderately deep, reddish-yellow, texture-contrast soils, which overlie a hardpan (JJ2). Also on the upper slopes, small areas of deep, red gradational sandy soils supporting low woodlands of yellow jacket-applejack (JJ1) occur at random. Exposures of the underlying ironstone hardpan appear as steep scarps with shallow rocky, gradational soils with mid-tall forests of lancewood (JJ3), whereas the lower slopes have deep texture-contrast profiles with yellowish brown clayey subsoils and tall woodlands of poplar box, bloodwood, and silver-leaved ironbark (JJ4). The drainage depressions have soil types ranging from young sandy alluvial deposits of variable depths supporting tall woodlands of poplar box, to silty loams on incised stream-banks with river red gum, to heavy clay soils on the lower reaches with brigalow (JJ5). Alluvial outwash fans adjacent to the lower drainage depressions are mostly cleared, but once supported woodlands of poplar box, silver-leaved ironbark and ghost gum on deep uniform sandy loam soils (JJ6).

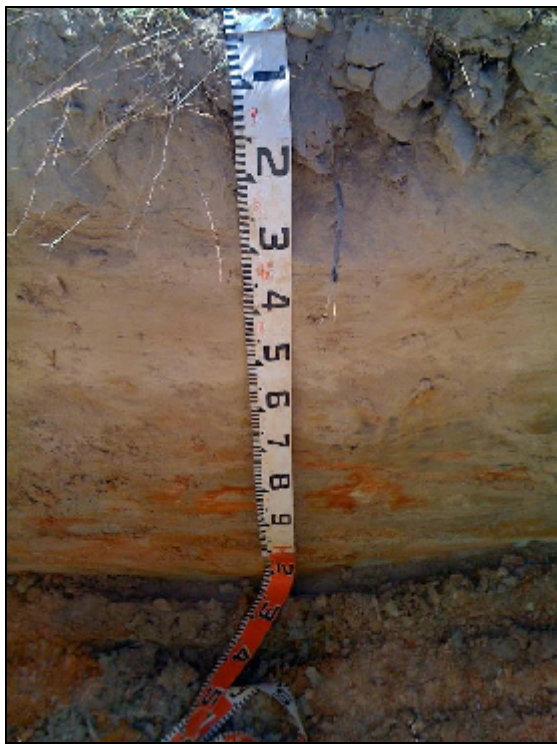
Plate 4.1: JJ2 – Grey Sodosol

Soil Description; The Grey Sodosol observed at Site 31 is a texture contrast soil that generally consists of grey loamy sand overlying a bleached loamy sand A2 horizon and a mottled grey sandy clay loam. The profile ranges from slightly acid to moderately acid pH, is non-saline with very low fertility characteristics. The topsoil is marginally sodic, and becomes sodic with depth. Structure in the upper profile is apedal, with subsoil structure being moderate with 10 - 20mm blocky peds. The analytical information of the representative site is presented in **Figure JJ2 – A** and **Table 14** below. The clay subsoil was not subject to laboratory analysis, and texture was determined by field observation.

Management; This soil is unsuitable for stripping and re-use in rehabilitation due to the sodic nature of the material throughout the profile. The soil would require erosion and sediment control structures to be implemented if disturbed.

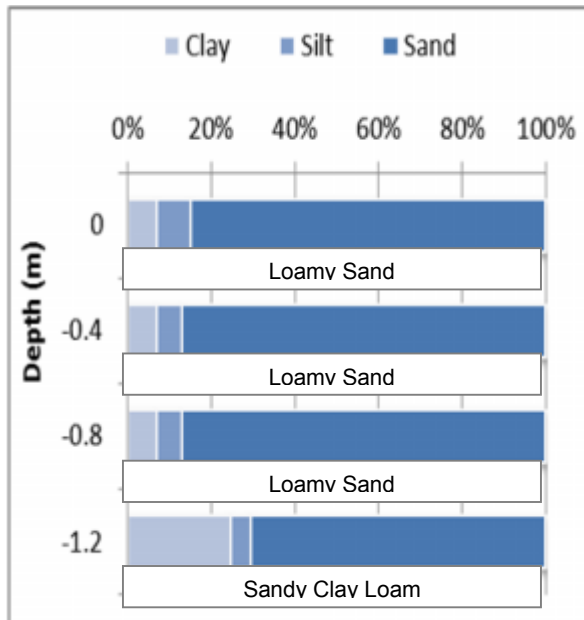
Figure JJ2 - B: Particle Size Analysis

Figure JJ2 - B shows the soil texture throughout the profile, and **Figure JJ2 - C** shows the trend of exchangeable cations with depth. The full suite of analytical results for this soil type can be found in **Appendix 3**. The lower layer PSA was based on field observations.

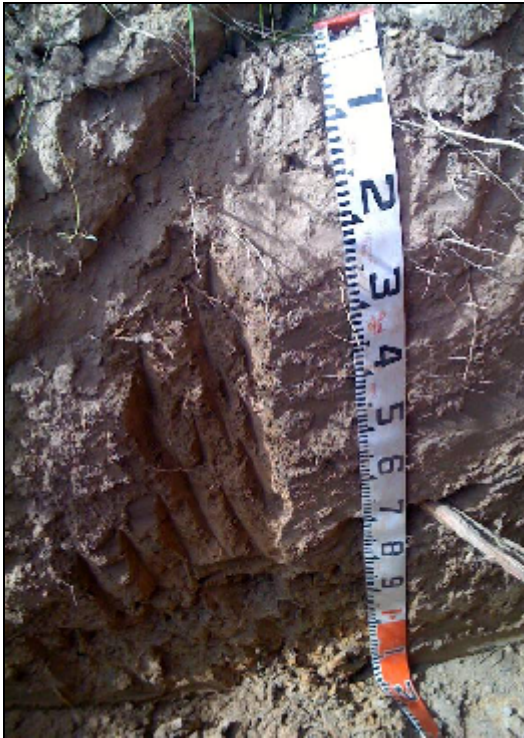
Plate 4.2: JJ3 – Grey Chromosol

Soil Description; The Grey Chromosol observed at Site 32 is a texture contrast soil that generally consists of grey sand overlying grey sandy clay. These well drained topsoils have apedal structure, whilst the poorly drained subsoils are moderately structured with 10mm sub angular blocky peds. Laboratory analysis was not undertaken for this soil type. The above description is based on field observations, however the following information applies to the land unit: The sandy topsoil of this soil type is prone to sheet erosion which has been enhanced by cattle grazing in the area.

Management; The sandy texture and apedal structure of this soil is unsuitable for stripping and re-use in rehabilitation, however in the event extra soil is required, this material can be blended with clay material to create a suitably textured material for rehabilitation. If treated, this soil can be stripped to 1.2m.

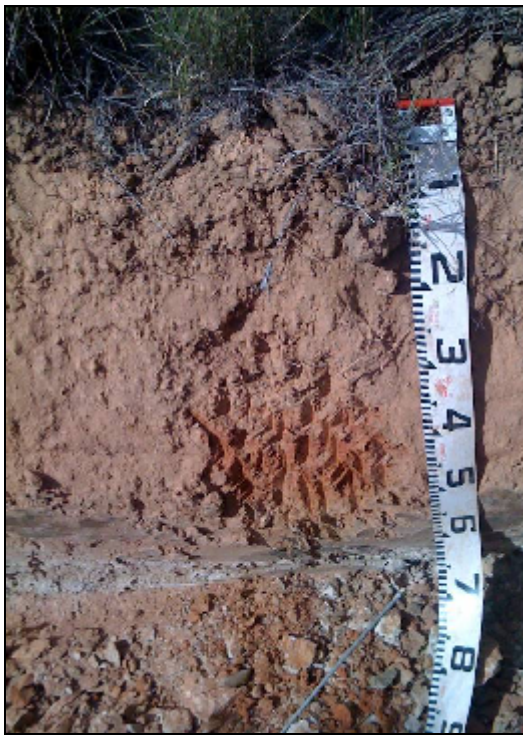
Plate 4.3: JJ4 – Brown Chromosol

Soil Description; The Brown Chromosol observed at Site 33 is a texture contrast soil that generally consists of brown to red silty loam overlying grey medium clay. These well drained topsoils are moderately acidic, non saline and non sodic with very low fertility characteristics. The poorly drained subsoil is slightly acidic, non saline and marginally sodic with low fertility characteristics. Structure in the topsoil is weak with blocky peds of 7mm, through to apedal blocky peds in the subsoil. The analytical information of the representative site is presented in **Figure JJ4 - A** and **Table 15** below.

Management; The silty loam topsoil does not display any specific management risk related to potential disturbance during stripping. The upper layers exhibit structure and chemical characteristics that would be suitable as surface cover in rehabilitation. The recommended stripping depth of the topsoil is 0.4m. The recommended stripping depth of the subsoil is 0.4 m, if the clay subsoil is blended with sandy material before reuse in rehabilitation.

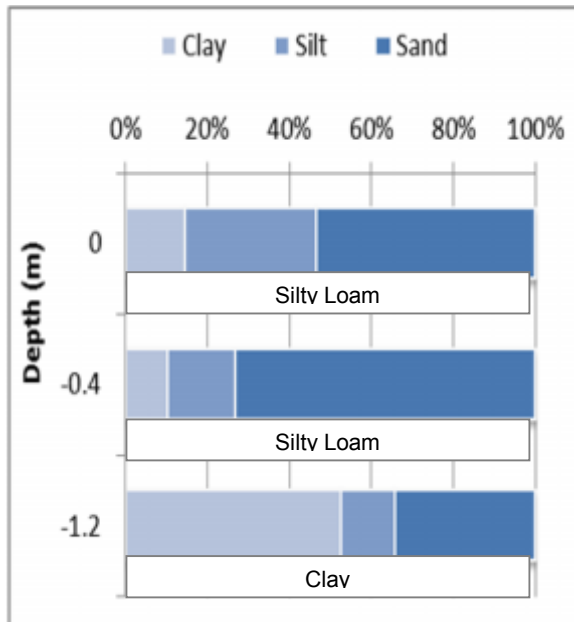
Figure JJ4 - B: Particle Size Analysis

Figure JJ4 - B shows the soil texture throughout the profile, and **Figure JJ4 - C** shows the trend of exchangeable cations with depth. The full suite of analytical results for this soil type can be found in **Appendix 3**.

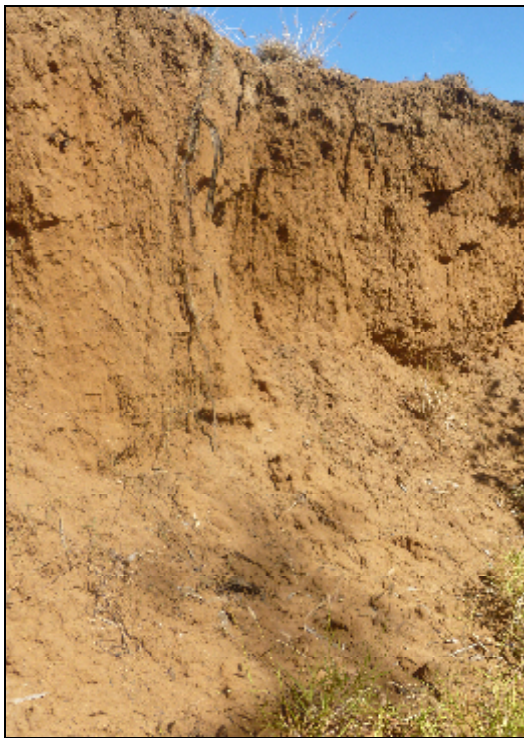
Plate 4.4: JJ5 – Tenosol

Soil Description; The Tenosol observed at Site 42 is a texturally uniform to gradational soil that generally consists of strong brown loamy sand overlying light brown loam. These well drained soils are slightly acidic in the topsoil to neutral through the profile. They are non-saline and non sodic with very low fertility characteristics. Structure in the topsoil is weak with platy peds of 20 – 50mm, through to apedal structure in the subsoil. Stones of 10mm are at a 10 per cent presence in the subsoil. The analytical information of the representative site is presented in **Figure JJ5 - A** and **Table 16** below.

Management; This soil type does not display any specific management risk related to potential disturbance during stripping. This material is not suitable for stripping and re-use in rehabilitation unless blended with clay material before re-spreading to increase water holding capacity. The potential stripping depth of this soil is 1.2 m, providing it is mixed with clay material.

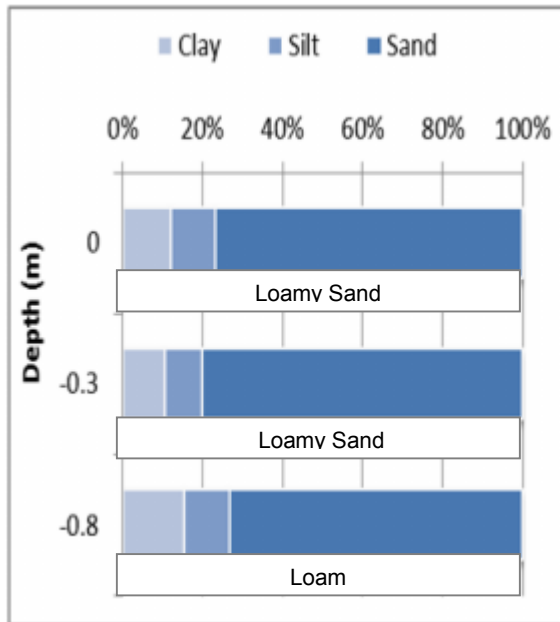
Figure JJ5 - B: Particle Size Analysis

Figure JJ5 - B shows the soil texture throughout the profile, and **Figure JJ5 - C** shows the trend of exchangeable cations with depth. The full suite of analytical results for this soil type can be found in **Appendix 3**.

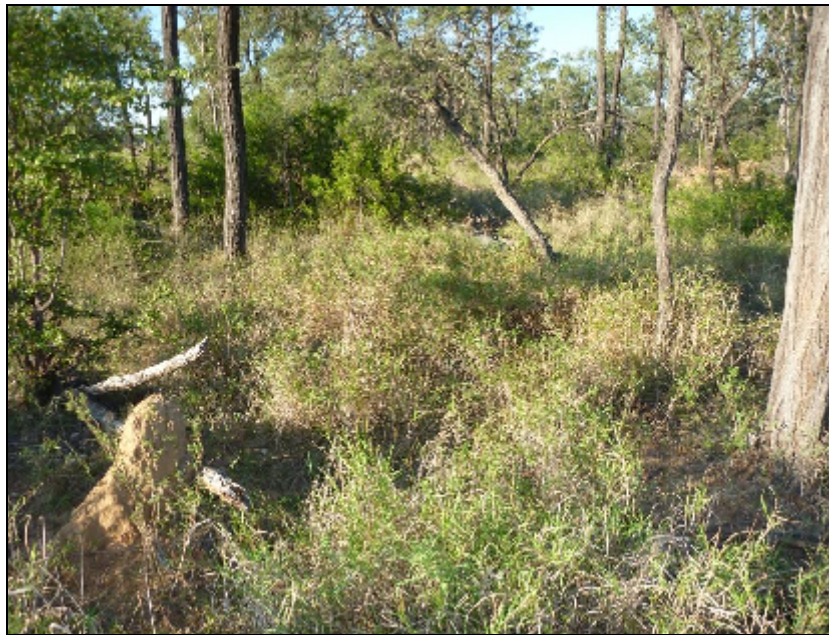
Plate 5: Lambton Meadows Land System (LM2)

The Lambton Meadows land system represents an extensive alluvial fan, extending in from the south east into Lagoon Creek which runs north through the centre of the lease. The soils on the upper slopes (LM1) overlie a hardpan, and consist of Yellow Chromosols texture-contrast profiles with sodic, reddish yellow, clay loam subsoils, which support tall open woodlands of silver-leaved ironbark, with occasional ghost gum and poplar box. The lower slopes (LM2) also have Sodosols which are texture-contrast soils but the mottled sandy clay subsoil is sodic.

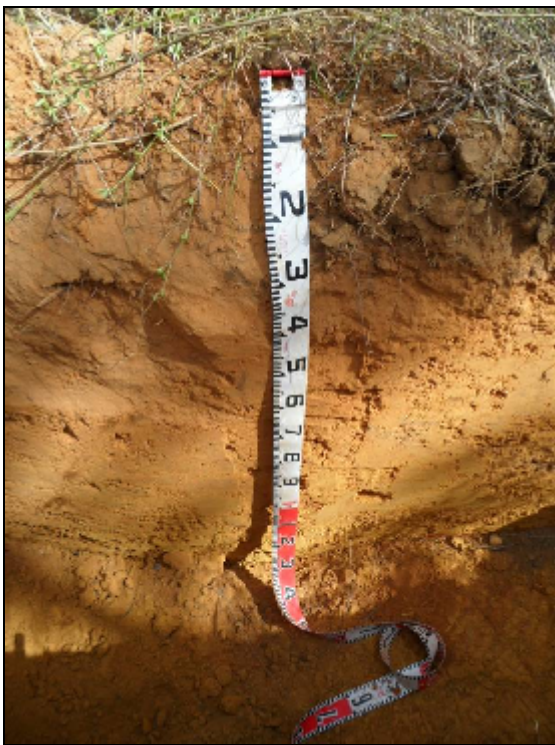
Plate 5.1: LM2 – Stratic Rudosol

Soil Description; The Stratic Rudosol observed at Site 47 is a young texturally layered soil that generally consists of light brown loamy sand through yellow loam overlying yellow clay loam. These well drained soils are slightly acid to moderately acid, non saline and non sodic with very low fertility characteristics. Structure is moderate in the upper layer trending to apedal and weak in the lower layers. The analytical information of the representative site is presented in **Figure LM2 - A** and **Table 17** below.

Management; Generally the soil does not display any specific management risk related to potential disturbance during stripping. The soil is suitable for use in rehabilitation, however the upper sandy layers would benefit by blending with a clay material to improve the water holding capacity. The recommended stripping depth of this soil is 1.2 m.

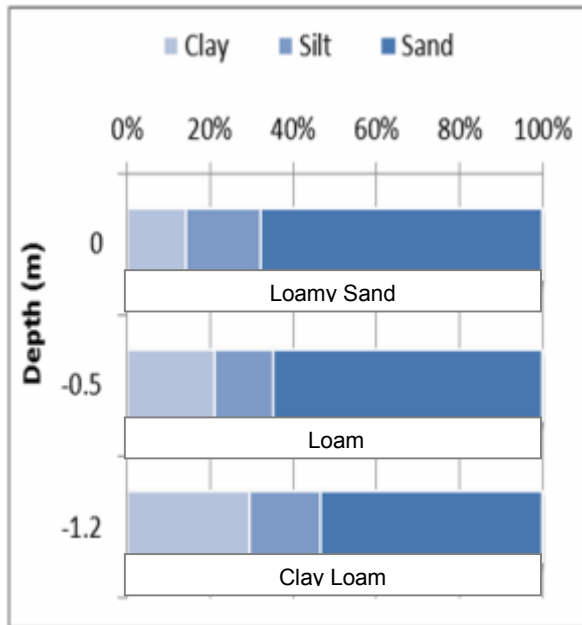
Figure LM2 - B: Particle Size Analysis

Figure LM2 - B shows the soil texture throughout the profile, and **Figure LM2 - C** shows the trend of exchangeable cations with depth. The full suite of analytical results for this soil type can be found in **Appendix 3**.
