Soil and Land Suitability Assessment

Kevin's Corner

Kevin's Corner Project Environmental Impact Statement

Soil & Land Suitability Assessment

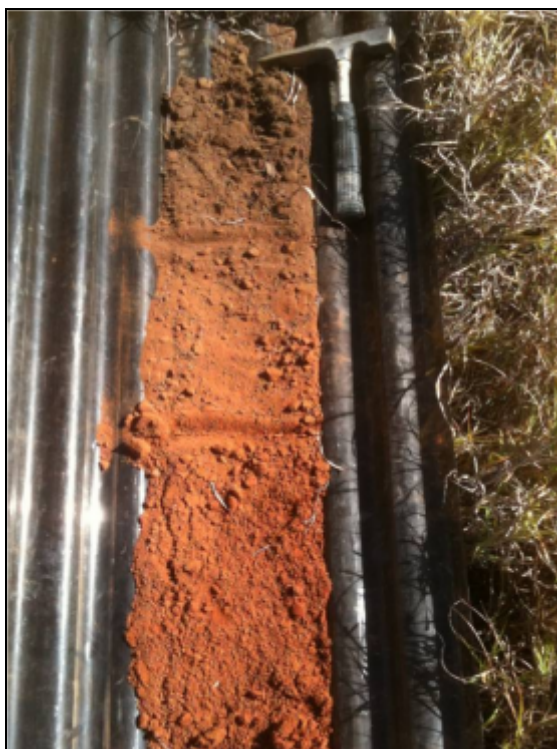
Plate 5.2: LM3 – Stratic Tenosol

Soil Description; The Stratic Tenosol observed at Site 91 is a texturally uniform soil that generally consists of brown loamy sand to sand overlying brown red to red loamy sand. These well drained soils are slight acidity to neutral through the profile. They are non-saline and non sodic with very low fertility characteristics. Structure in the topsoil is weak with platy peds of 20 – 50mm, through to apedal structure in the remainder of the profile. The analytical information of the representative site is presented in **Figure LM3 – A** and **Table 18** below.

Management; This soil type does not display any specific management risk related to potential disturbance during stripping. This material is not suitable for stripping and re-use in rehabilitation unless blended with clay material before re-spreading to increase water holding capacity. The potential stripping depth of this soil is 1.2 m, providing it is mixed with clay material.

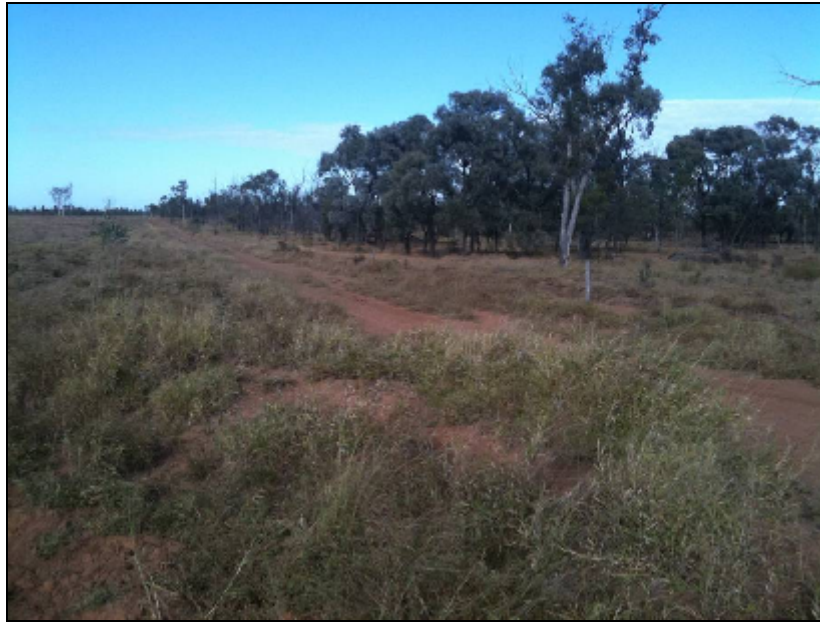
Plate 6: Degulla Land System (DA2)

The Degulla land system represents a large alluvial fan in the central north. The upper slopes (DA1) have Brown Chromosols which are yellowish-brown texture-contrast soils supporting open woodlands of silver-leaved ironbark and poplar box. The lower slopes (DA2) generally have deeper topsoils, resulting from accumulations of sandy wash material. Additional plant species such as bloodwood, white cypress pine and ironwood are common. Land unit DA3 is a complex unit comprising mostly of poplar box on deep soils in the drainage depressions but interspersed with areas of land unit DA2, which vary in size and shape.

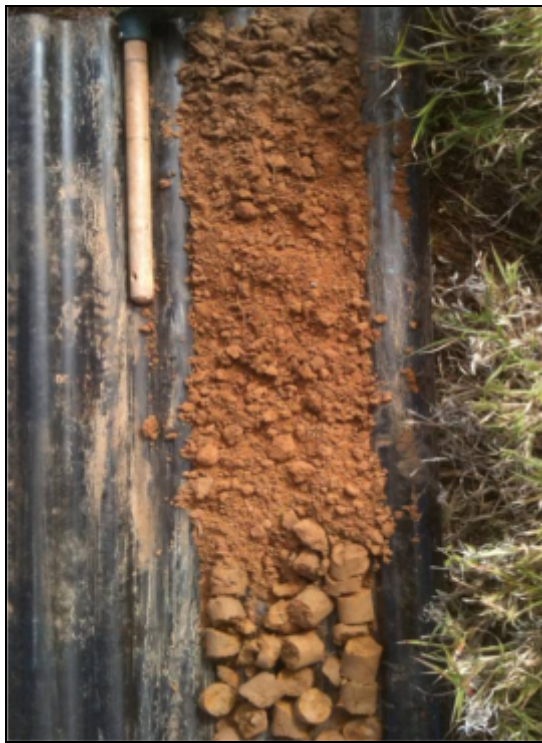
Plate 6.1: DA2 – Red Chromosol

Soil Description; The Red Chromosol observed at Site 95 is a texture contrast soil that generally consists of light brown loamy sand overlying reddish brown sandy loam to yellow light medium clay. These well drained topsoils and poorly drained subsoils have a neutral to mildly alkaline pH, are non-saline with very low fertility characteristics. The profile is non sodic. Structure in the topsoil is moderate with platy peds of 5 – 10mm, through to strong structure 20mm sub angular blocky peds in the subsoil. The analytical information of the representative site is presented in **Figure DA2 - A** and **Table 19** below.

Management; The sandy topsoil does not display any specific management risk related to potential disturbance during stripping. The uppermost layers exhibit structure and chemical characteristics that would be suitable as surface cover in rehabilitation. The subsoil not recommended for stripping given its high clay content. The recommended stripping depth of this soil is 0.5 m.

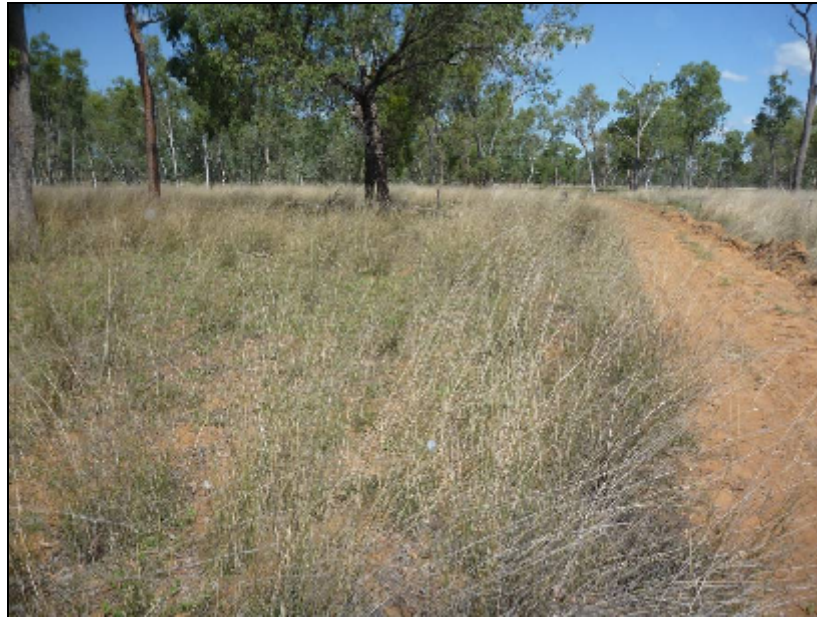
Plate 7: Lagoon Creek Land System (LC1)

The Lagoon Creek land system represents the extended alluvial floodplain of Lagoon Creek. Land unit LC1 is most common with a typical soil-vegetation association of Red Kandosols deep sandy loam gradational profiles with tall sparse woodlands of bloodwood-ghost gum. Numerous small depressions and drainage lines with Chromosols with clayey subsoils cut through this unit. The backplains (LC2) are easily recognised by the Vertosols with heavy clay soils and a characteristic gilgai micro-relief with tall sparse woodlands of blackbutt and a lower tree layer of brigalow. The drainage depressions and creeklines (LC3) have tall open woodlands of river red gum, usually on Tenosols with uniform sandy loam soils, however desert bloodwood and poplar box are common on the sandy levee banks and interfluves.

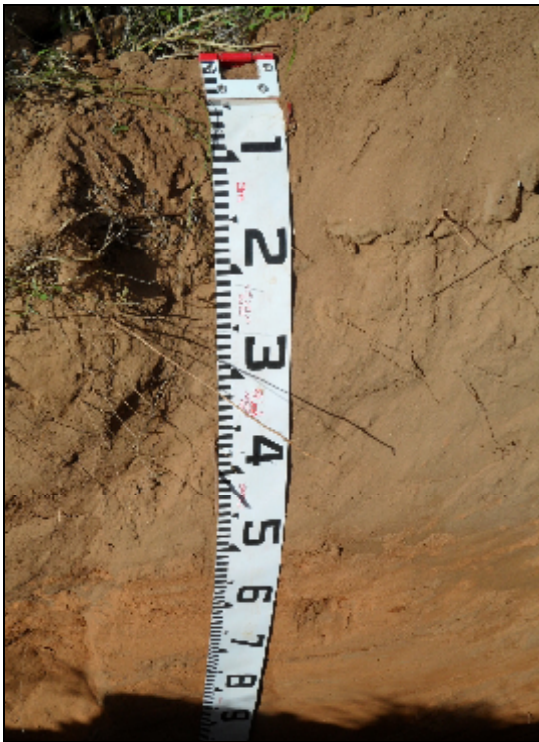
Plate 7.1: LC1 – Yellow Kandosol

Soil Description; The Yellow Kandosol observed at Site 5 is a gradationally textured soil that generally consists of light brown, pale yellow to yellow silty loam, loam, clay loam to silty clay loam layers throughout the profile that increase in clay content with depth. These well drained layers range from slightly acid in the topsoil, through neutral to mildly alkaline with depth, and are consistently non-saline with very low fertility characteristics. The profile is non sodic until approximately 50cm, where it becomes strongly sodic. Structure in the topsoil is weak with platy peds of 5 – 10mm, through to massive structure in the subsoil. Gravel is at 10 per cent presence in the subsoil. The analytical information of the representative site is presented in **Figure LC1 - A** and **Table 20** below.

Management; The silty loam topsoil does not display any specific management risk related to potential disturbance during stripping. The uppermost layers exhibit structure and chemical characteristics that would be suitable as surface cover in rehabilitation. The deeper subsoil not recommended for stripping given its increased clay content, strong sodicity and presence of gravel. The recommended stripping depth of this soil is 0.5 m.

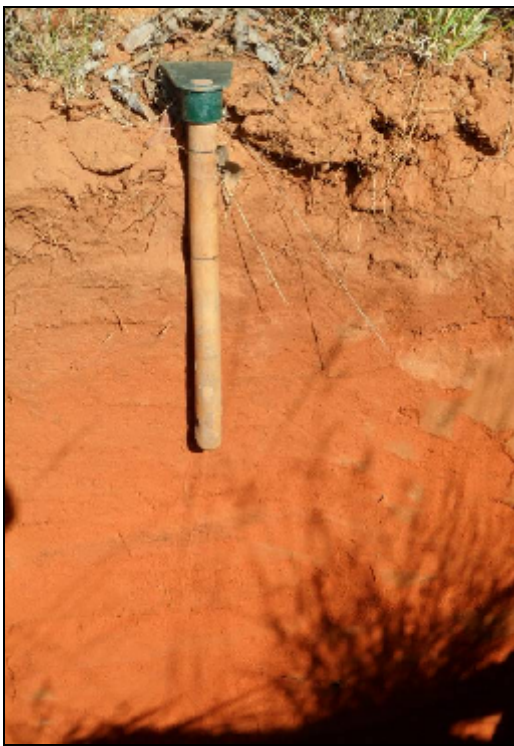
Plate 7.2: LC3 – Stratic Tenosol

Soil Description; The Stratic Tenosol observed at Site 45 is a texturally uniform soil that generally consists of light brown loamy sand overlying red loamy sand. These well drained soils have a slightly acid to moderately acid pH, and are non-saline with very low fertility characteristics. The topsoil is non sodic and the subsoil is marginally sodic. Structure in the topsoil is moderate with sub angular blocky peds of 20 – 30mm, through to weakly structured >10mm blocky peds in the subsoil. The analytical information of the representative site is presented in **Figure LC3 - A** and **Table 21** below.

Management; The loamy sand profile does not display any specific management risk related to potential disturbance during stripping. The structure and chemical characteristics are considered to be suitable as surface cover in rehabilitation if blended with clay material to increase the water holding capacity. The recommended stripping depth of this soil is 1.2 m, providing it is blended with clay material.

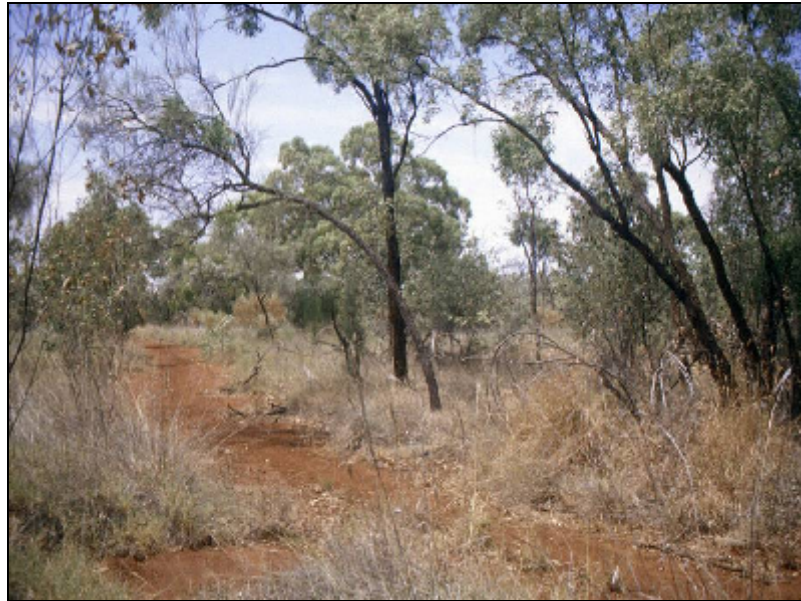
Plate 8: Desert Land System (DT1)

This land system represents an extensive sand plain stretching through the Flinders and Aramac Shires, with large areas also occurring in Belyando and Jericho Shires. The typical "desert country" (DT1) consists of mid-tall woodlands of Queensland yellow jacket, Clarkson's bloodwood, applejack, the occasional rusty jacket and a pasture dominated by spinifex on bright red, deep sandy gradational and texture contrast soils.
